Mitigation Plan for

Obion Creek (Phase II) and Little Joe Creek, Hickman County, Kentucky

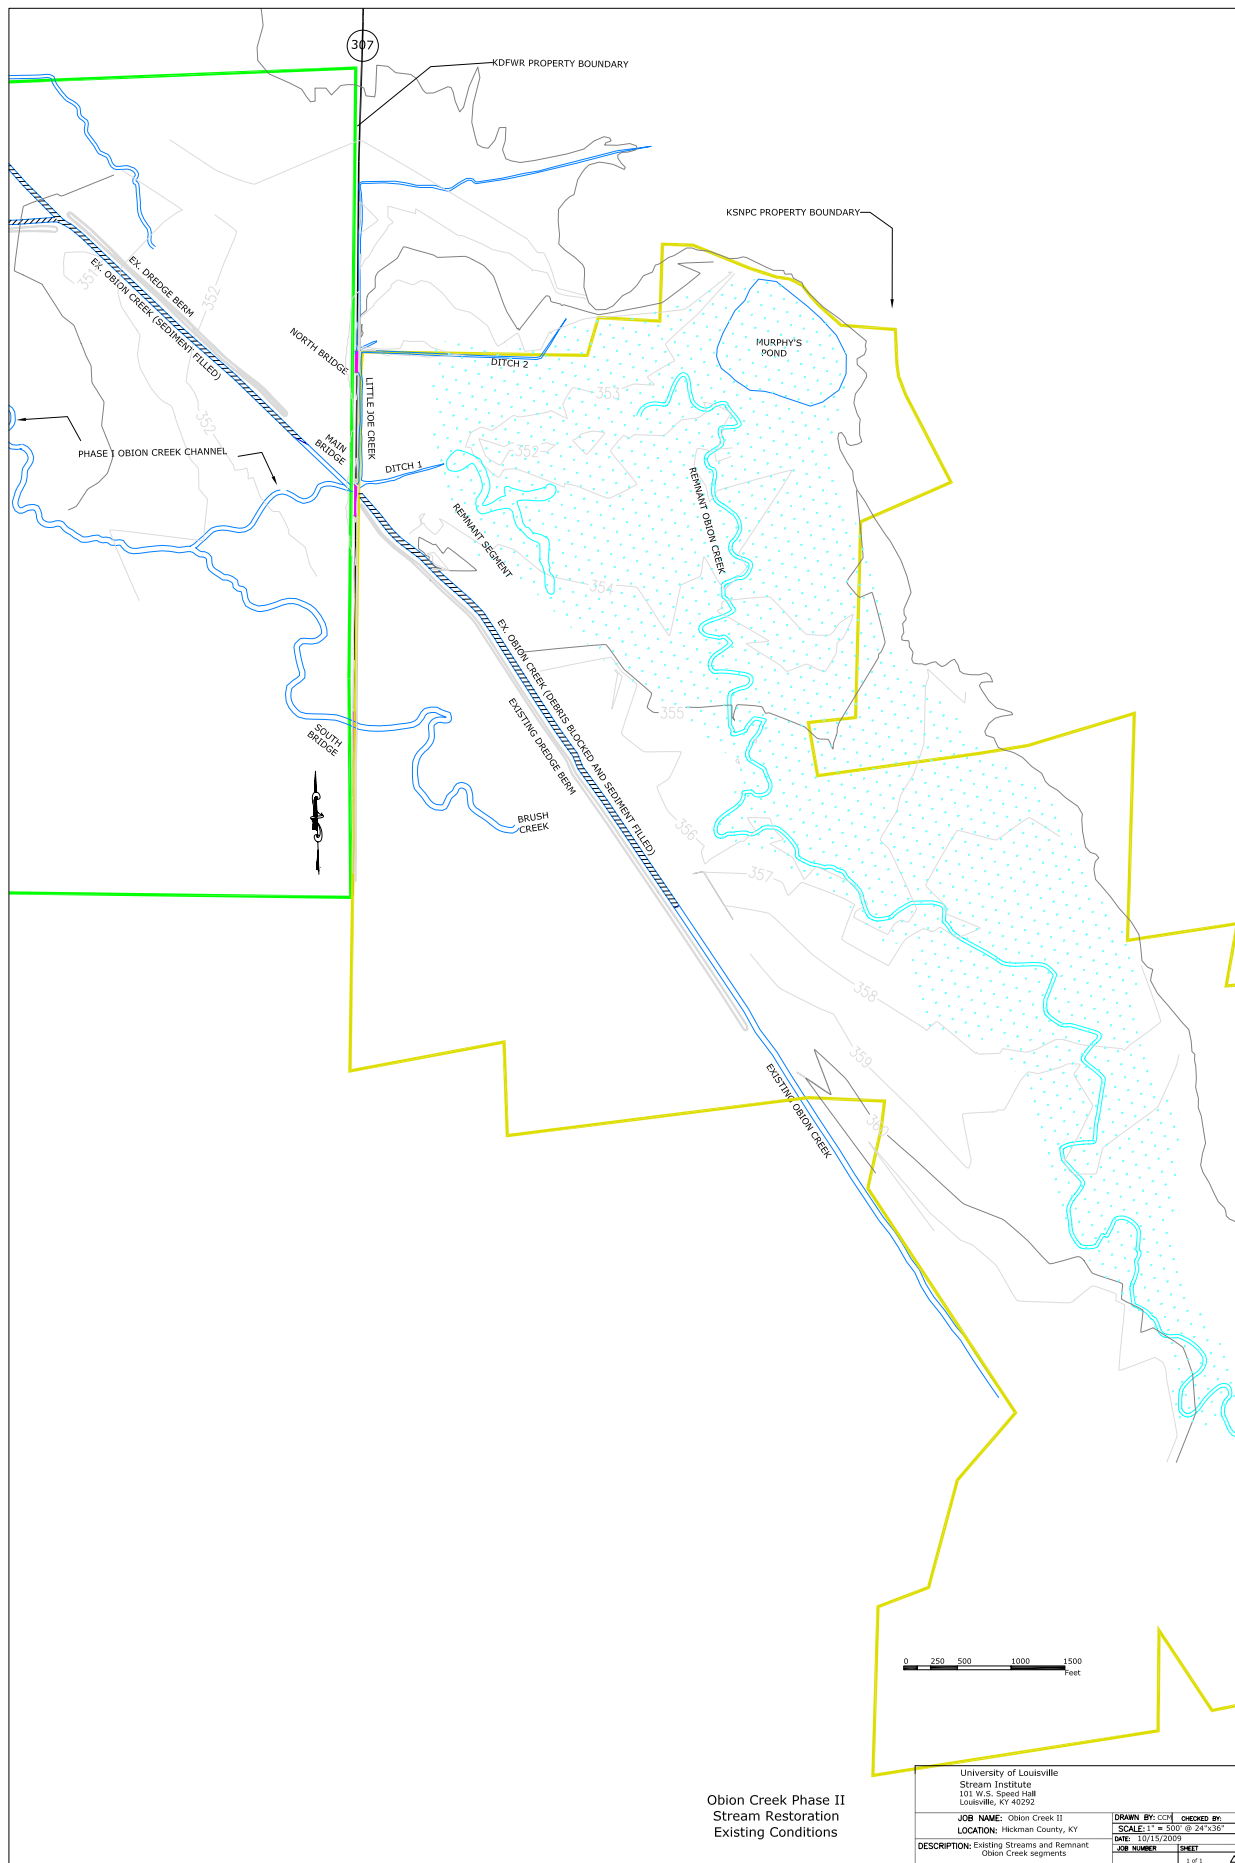
Figure 23 Existing channel planforms and site conditions. Remnant Obion Creek channel and remnant segment are both shown in aqua.

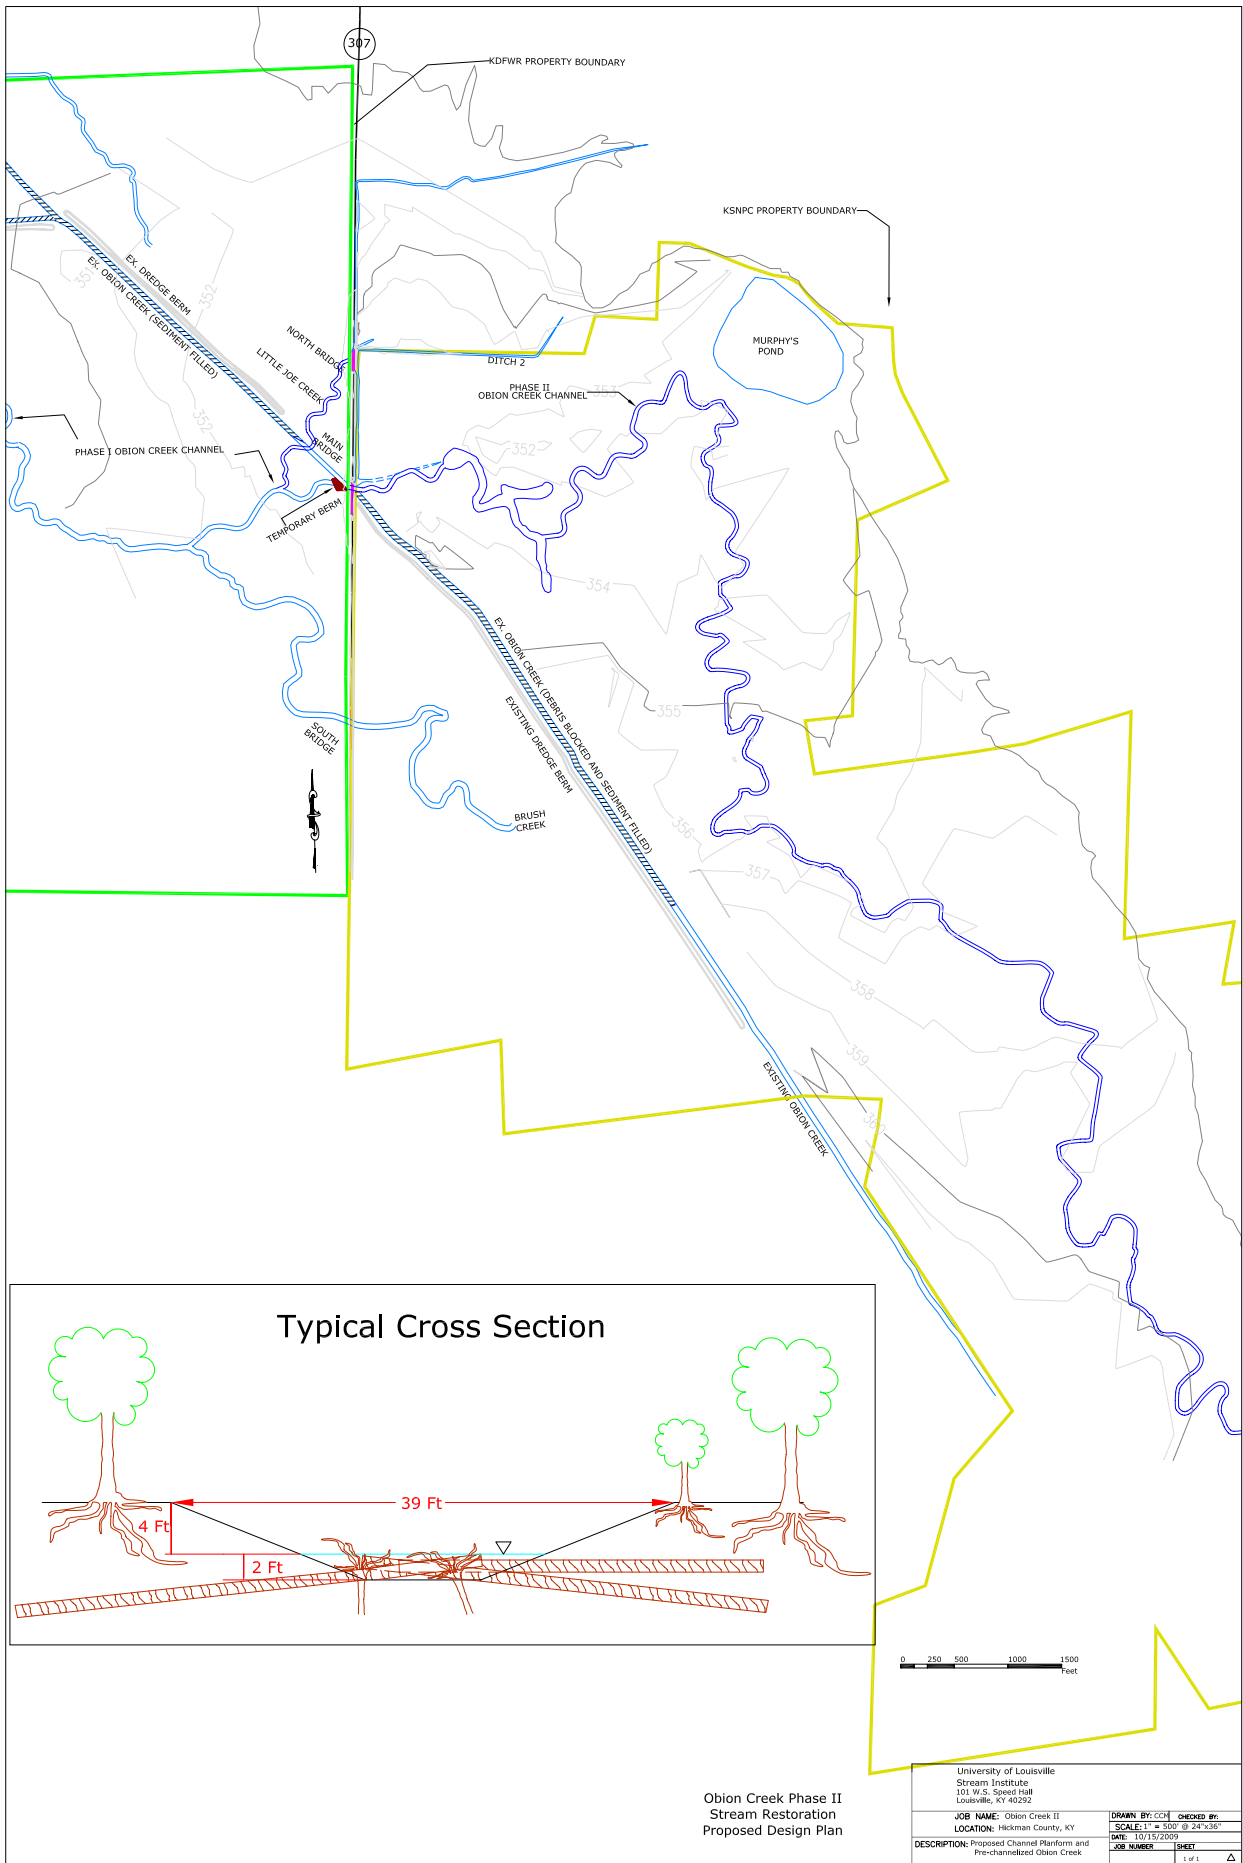
Figure 24 Obion and Little Joe restoration plan showing the temporary berm (in magenta) and a typical proposed cross section at the location of a grade control structure.

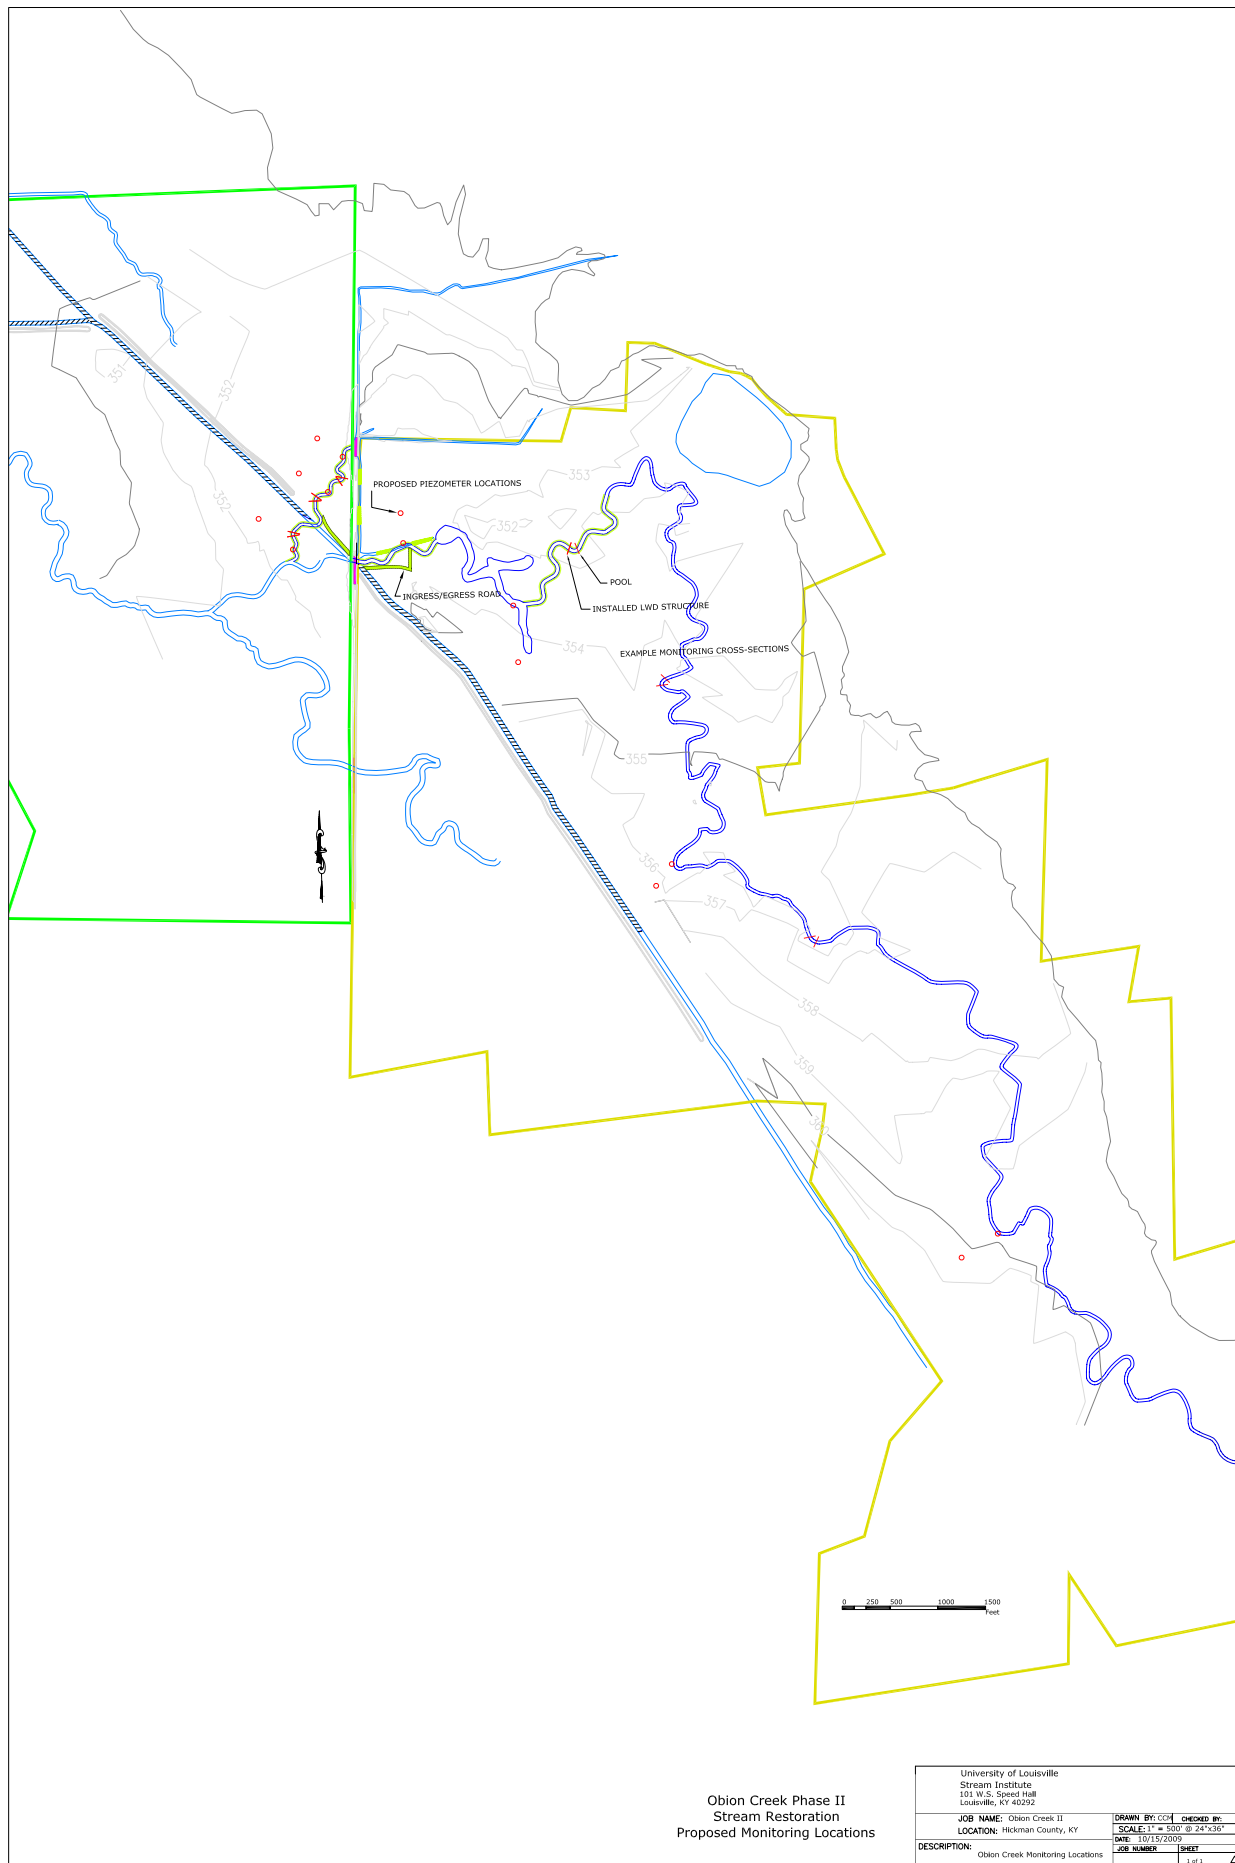
Figure 25 Obion and Little Joe restoration plan showing proposed monitoring locations. Vegetation monitoring areas—including potential ingress/egress paths, in-channel berms, and disturbance areas near the channels—are shown in light green. The approximate boundary of the mitigation site is shown in red. Monitoring locations are subject to change depending on as-built conditions.

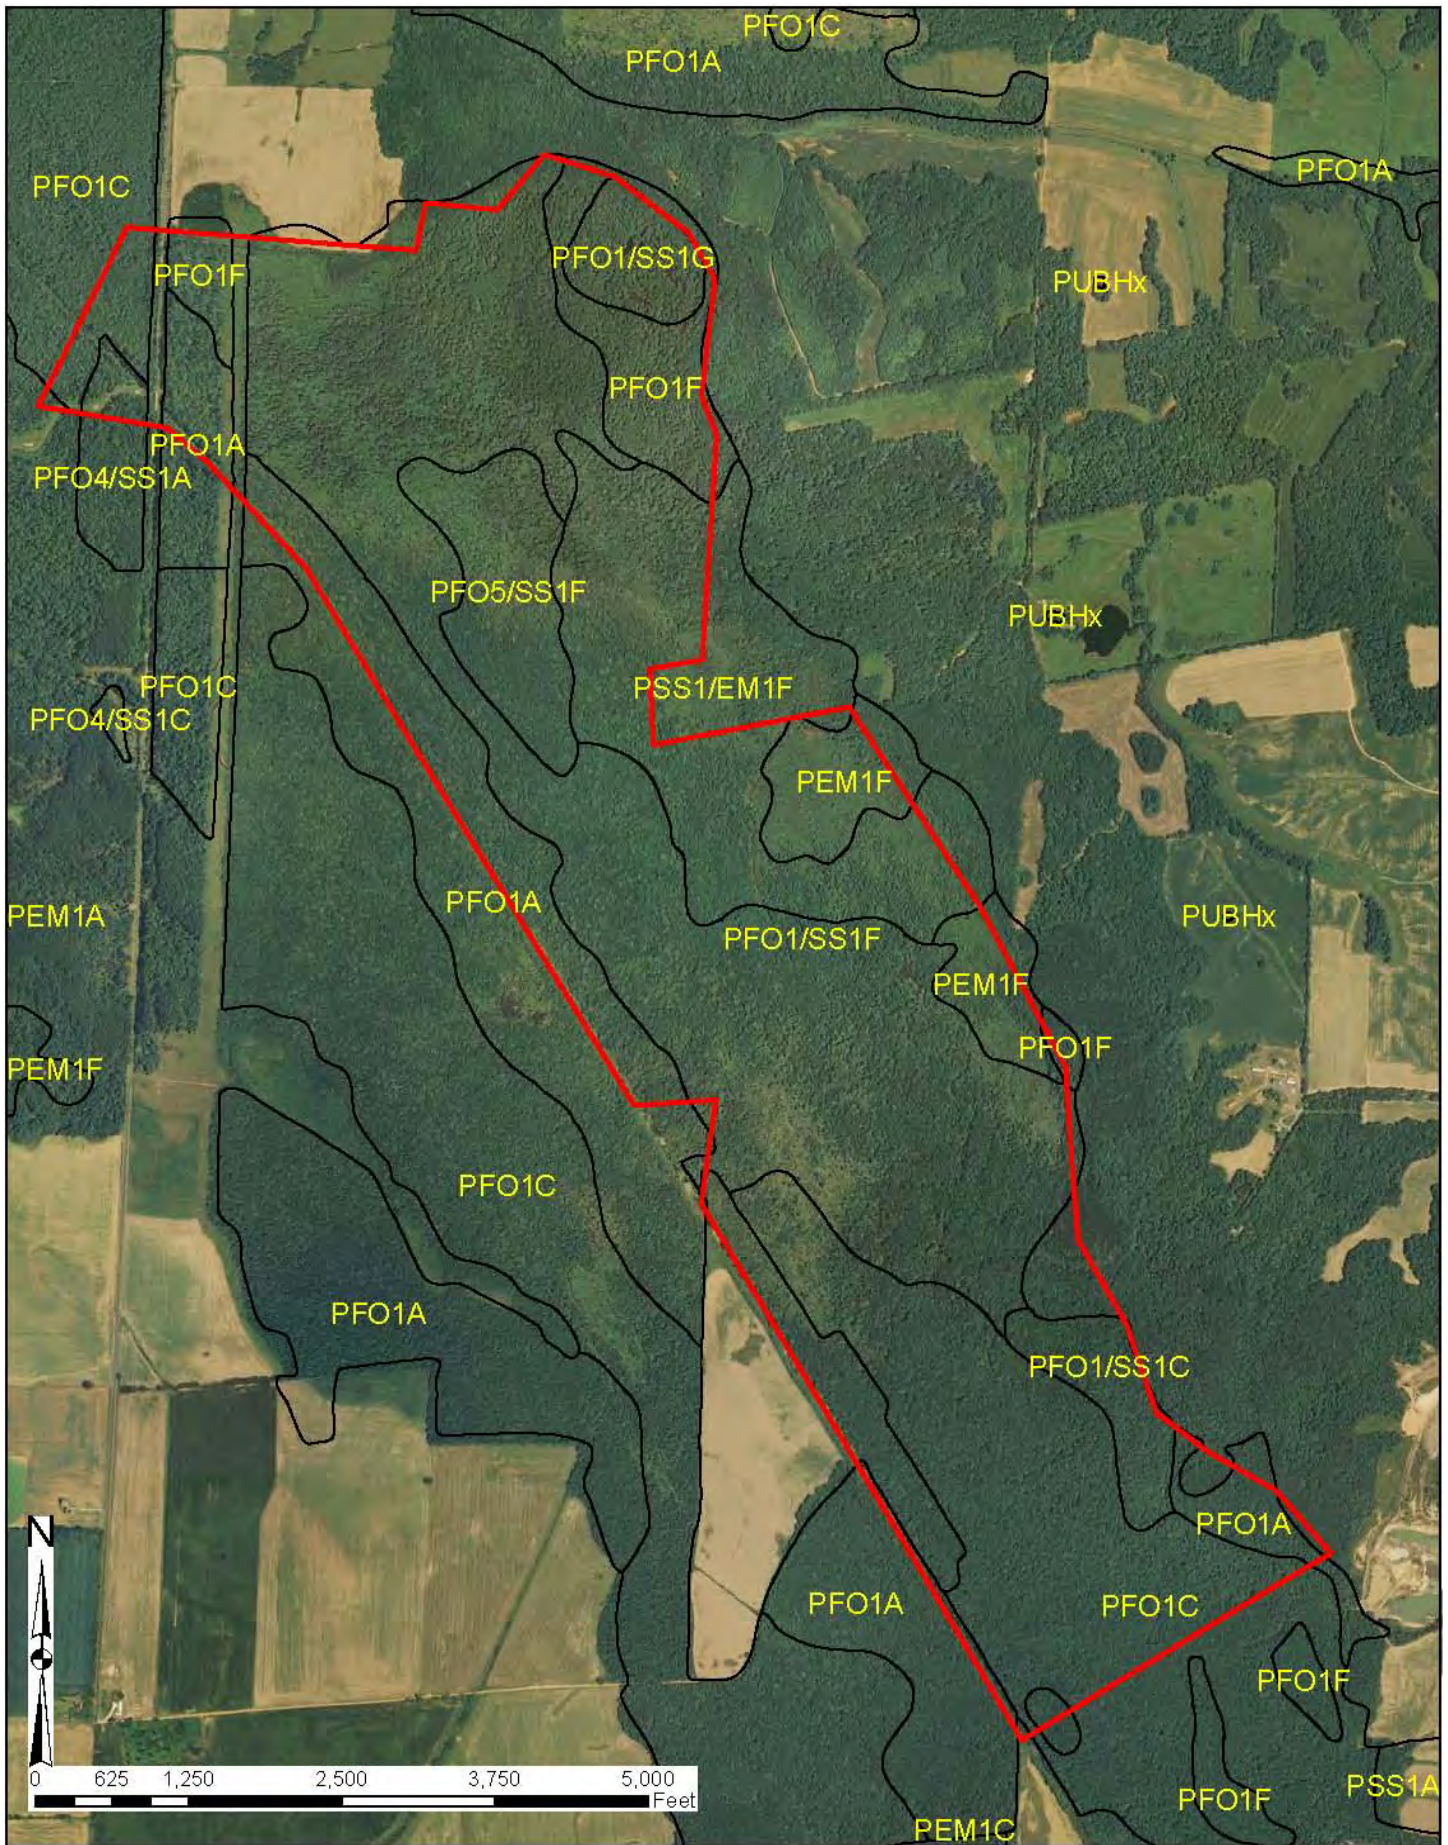
Figure C.1 NWI mapping: locations of existing wetlands (USFWS 2009).
