*Mitigation Plan for*

# **Obion Creek (Phase II) and Little Joe Creek, Hickman County, Kentucky**

Corps ID: MVM-2009-xxx-xxx  
KDOW AI# xxxxx

Submitted: November 11, 2009

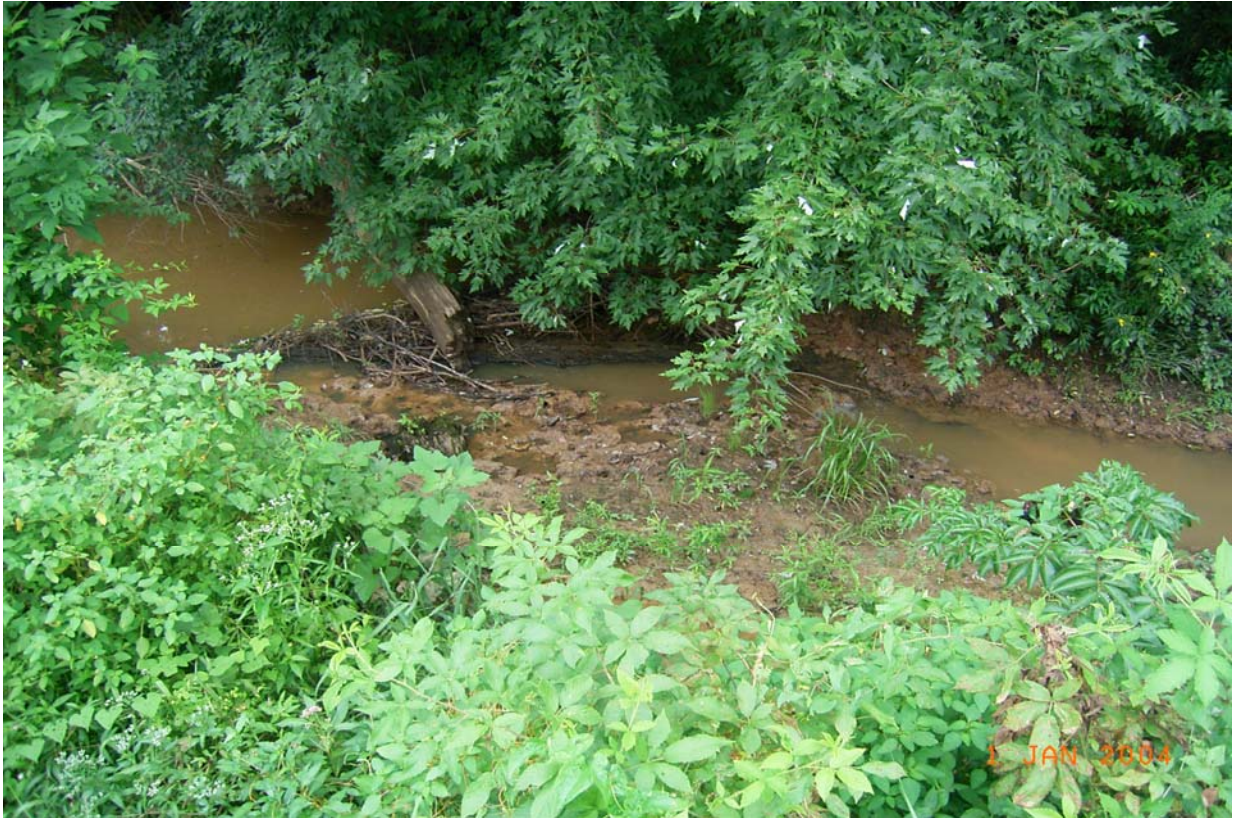
**Figure 10** Knickpoint progression through clay substrate of Little Joe Creek; woody debris placed by beavers.

- Figure 9 Little Joe Creek looking downstream along the upstream (east) side of the north KY-307 crossing.
- Figure 10 Knickpoint progression through clay substrate of Little Joe Creek; woody debris placed by beavers.

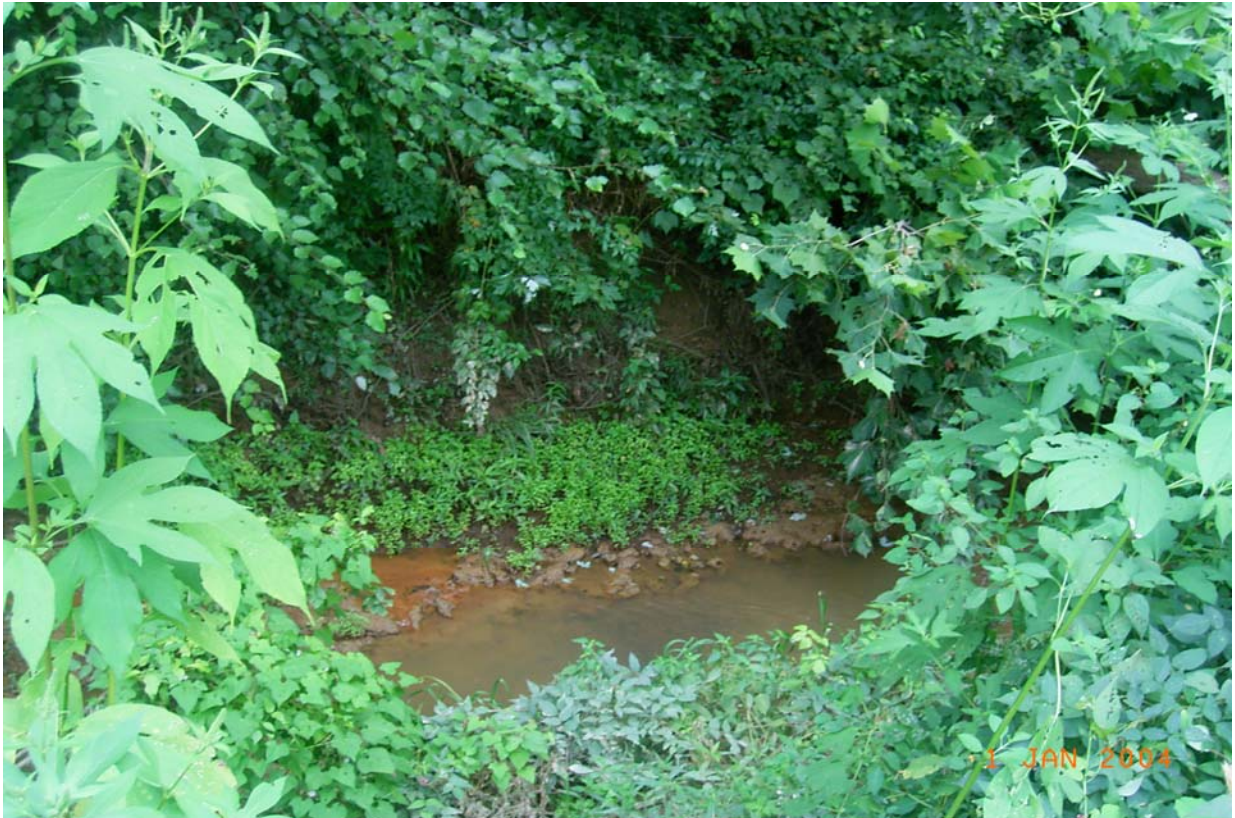
**Figure 11** Little Joe Creek: Clay substrate, vegetated low bench, and bank erosion.

- Figure 11 Little Joe Creek: Clay substrate, vegetated low bench, and bank erosion.
- Figure 12 Bank erosion on right bank side of Little Joe Creek; straight channel alignment.

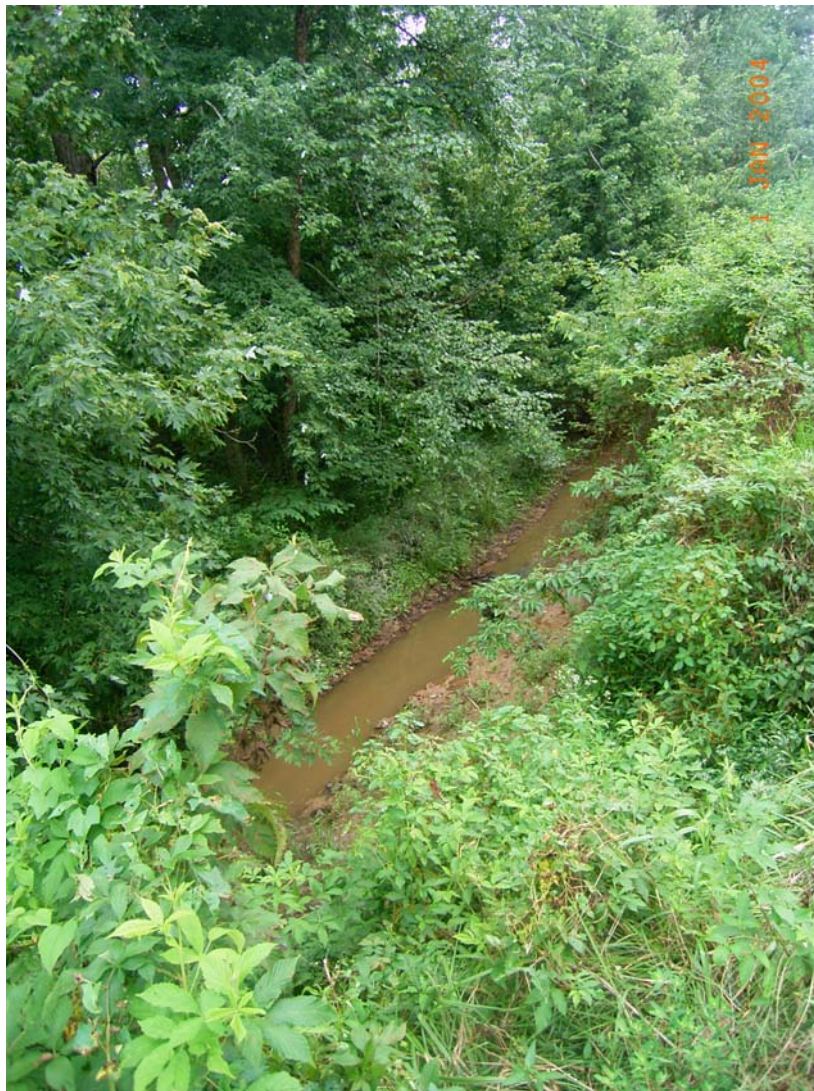
**Figure 12** (Right) Bank erosion on right bank side of Little Joe Creek; straight channel alignment.

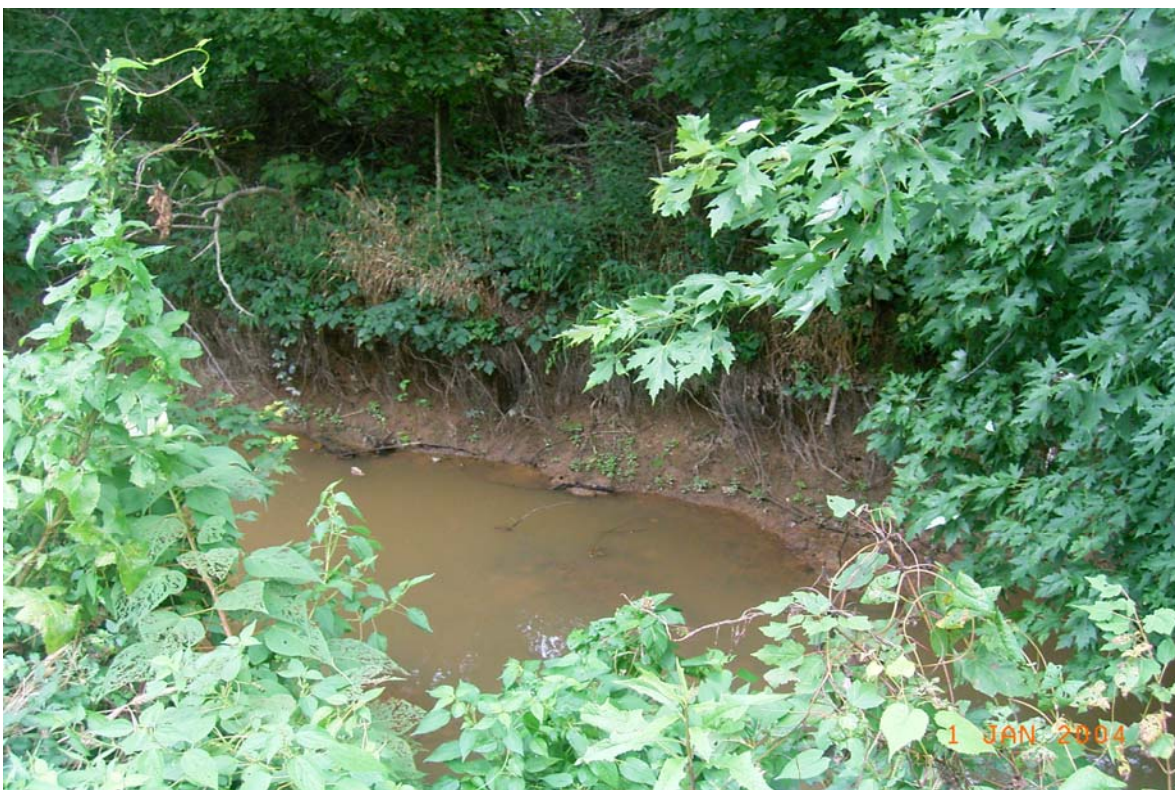
**Figure 13** (Below) Little Joe Creek: Undercut bank upstream of confluence with Ditch 1.

- Figure 13 Little Joe Creek: Undercut bank upstream of confluence with Ditch 1.
- Figure 14 Phase I Obion Creek channel downstream of KY-307 (downstream view).

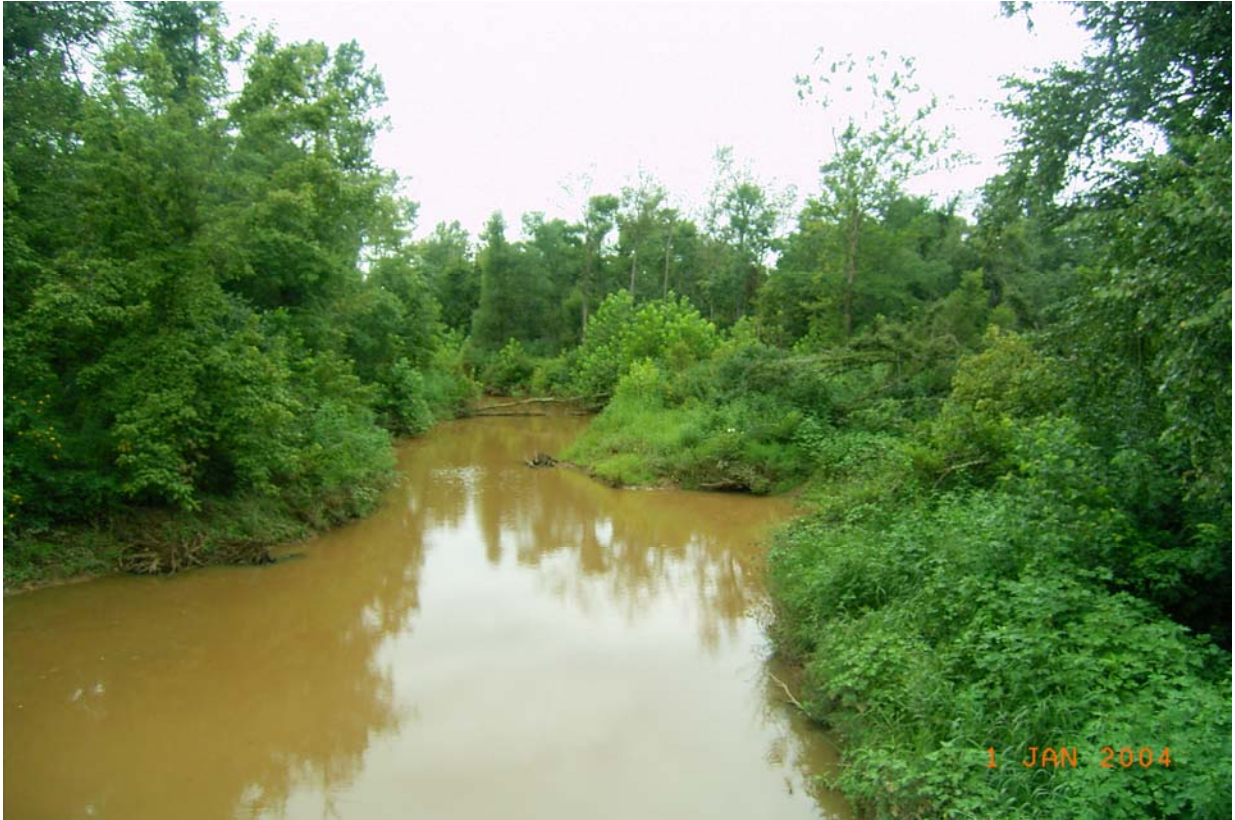
**Figure 14** Phase I Obion Creek channel downstream of KY-307 (downstream view).

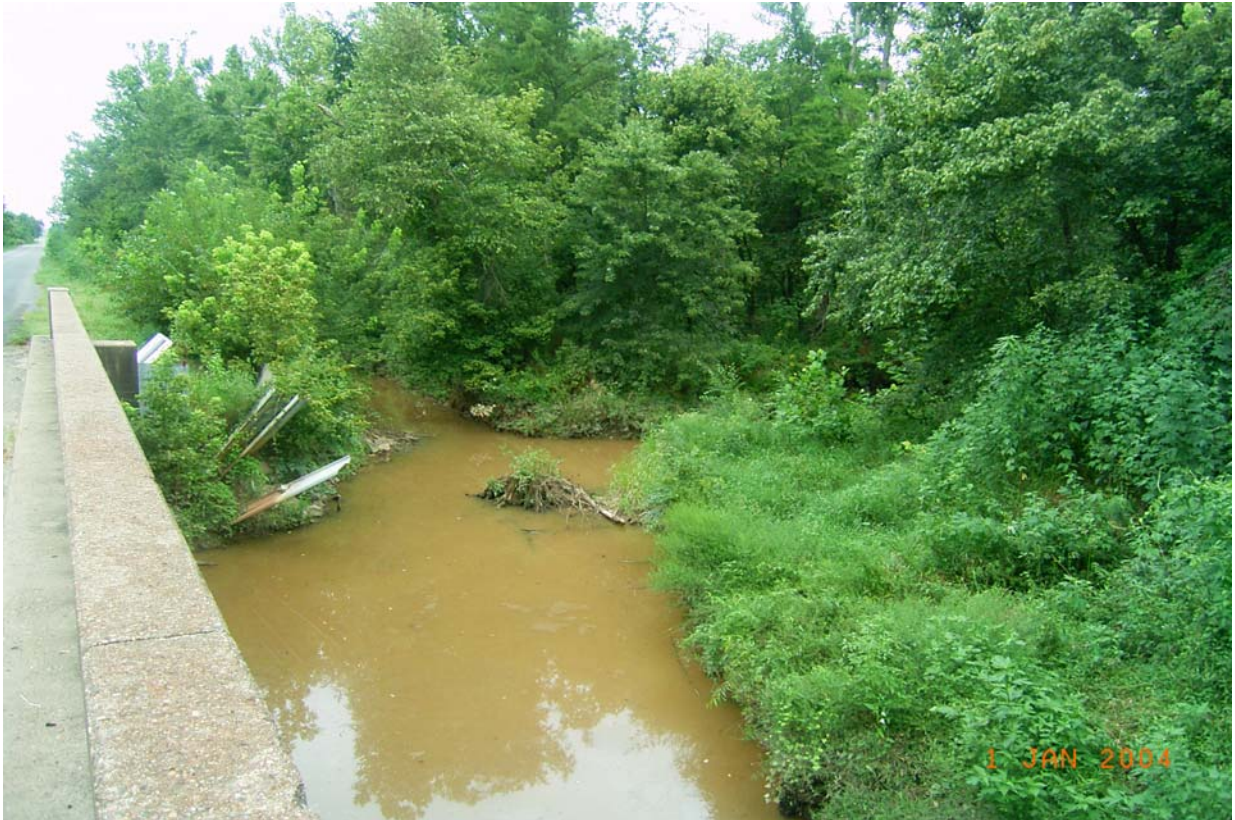
**Figure 15** Upstream view of confluences of Obion Creek (bottom of photo), Little Joe (center left), and Ditch 1 (center right).

- Figure 15 Upstream view of confluences of Obion Creek (bottom of photo), Little Joe (center left), and Ditch 1 (center right).
- Figure 16 Ditch 1 confluence with Little Joe Creek.

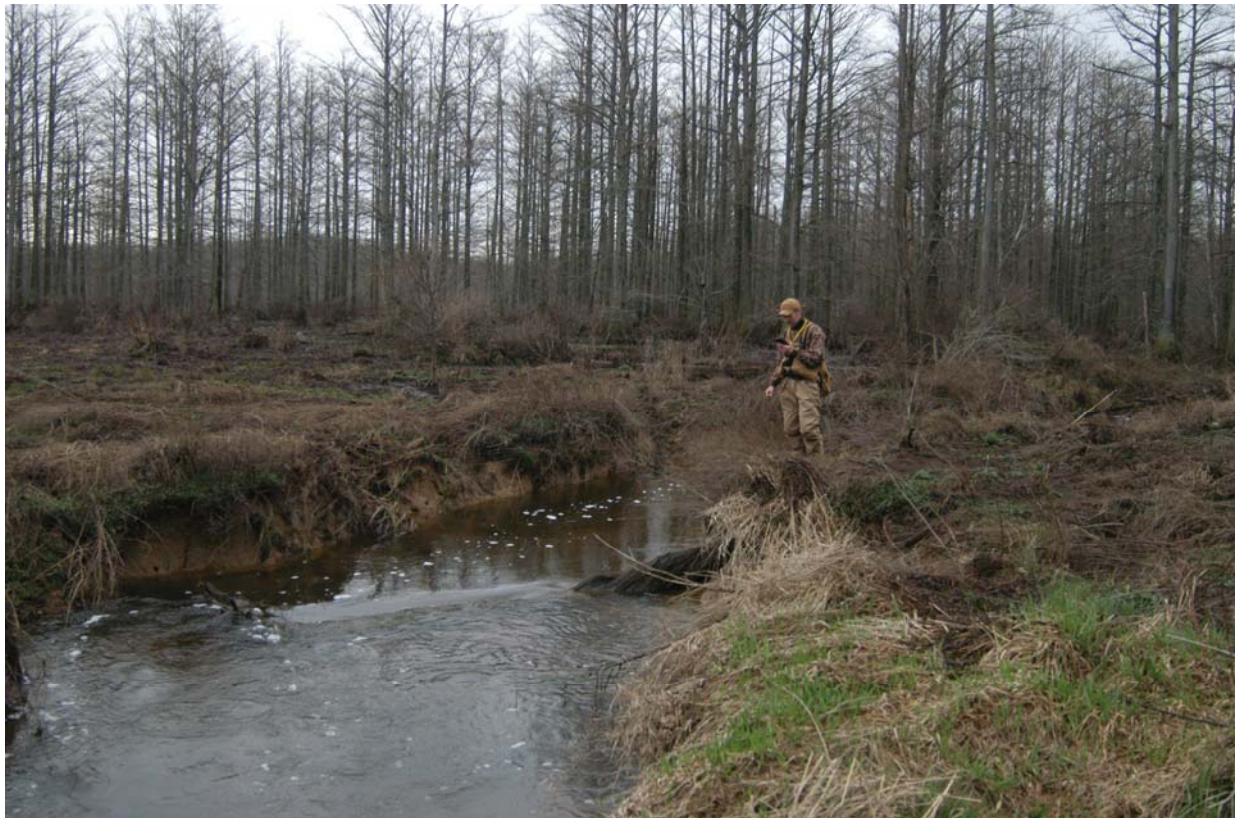
**Figure 17** Looking upstream at bank erosion on Ditch 1.

- Figure 17 Looking upstream at bank erosion on Ditch 1.
- Figure 18 Looking upstream at Ditch 1 headcut over main beaver dam (at edge of power line crossing).

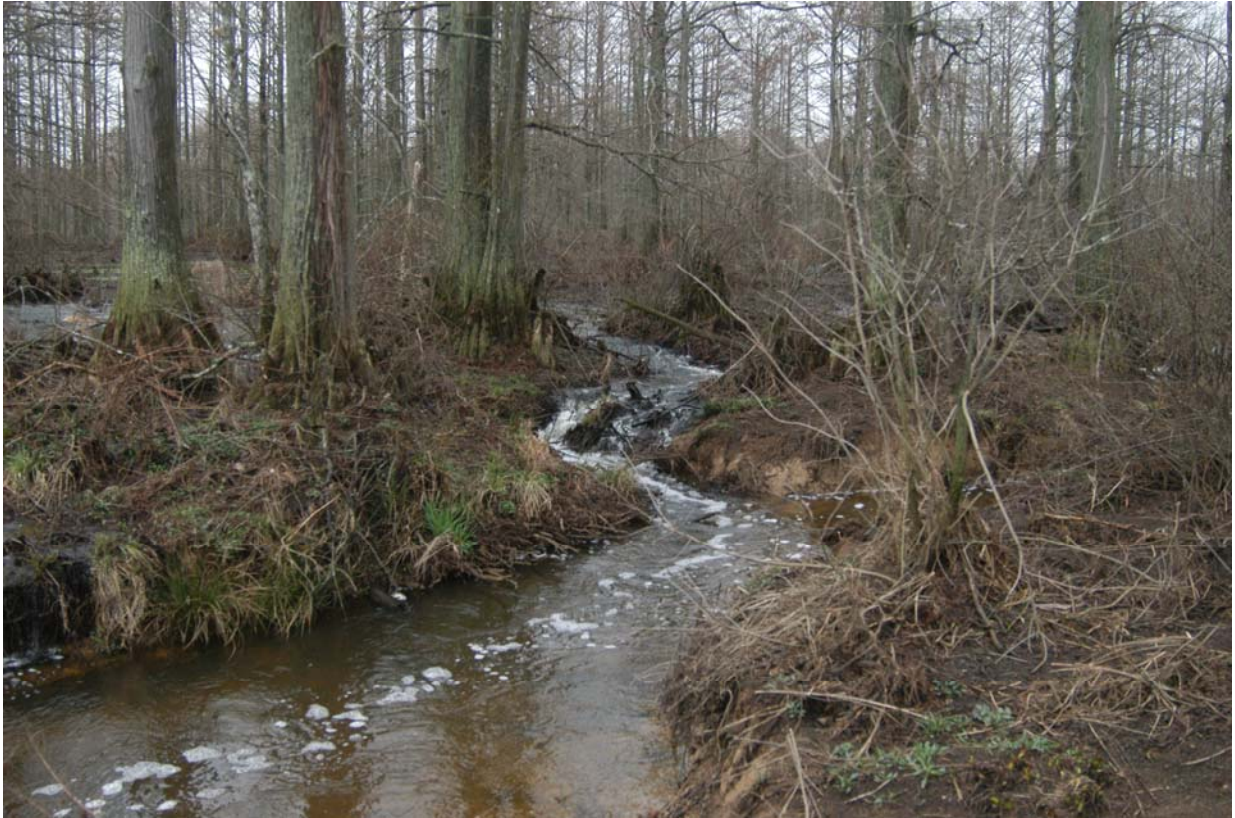
**Figure 18** Looking upstream at Ditch 1 headcut over main beaver dam (at edge of power line crossing).

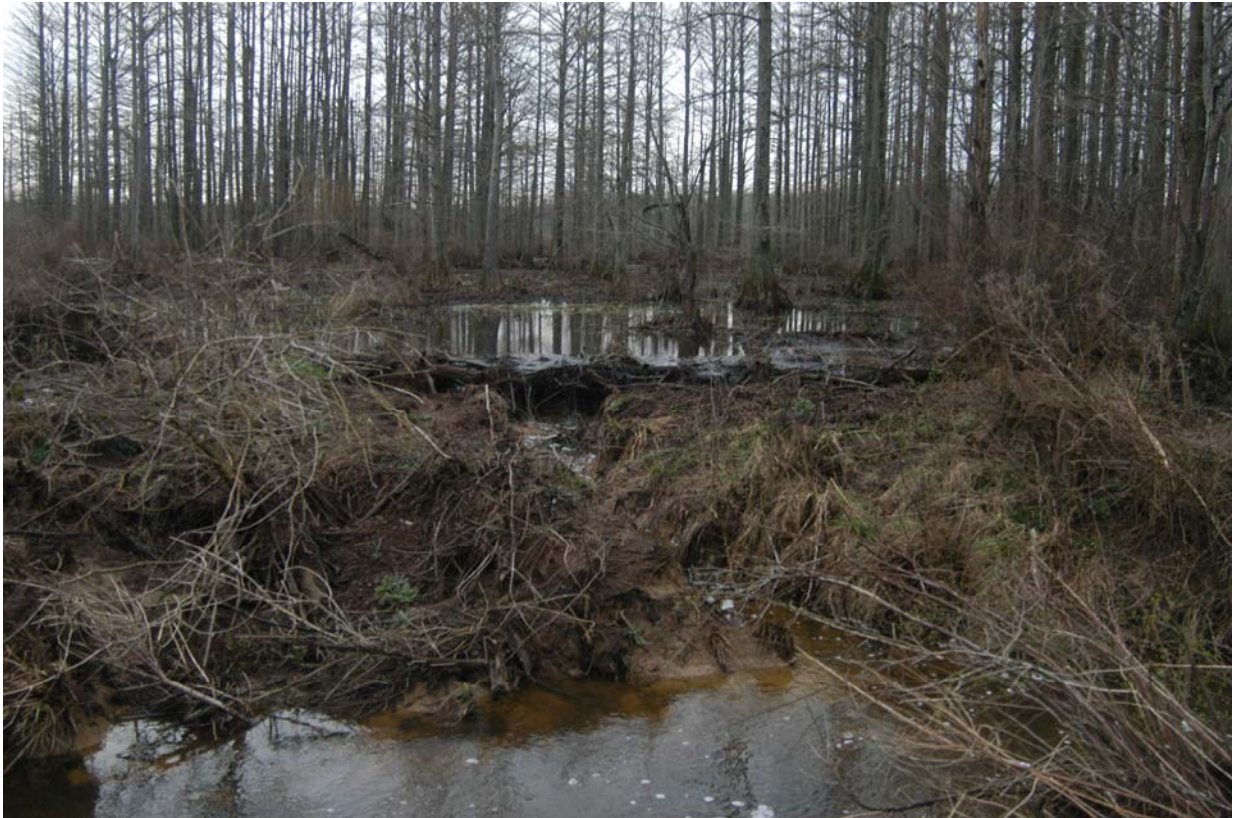
**Figure 19** Turned 90° to the left from preceding photo of Ditch 1. Headcut/bank erosion from main beaver dam.

- Figure 19 Turned 90° to the left from preceding photo of Ditch 1. Headcut/bank erosion from main beaver dam.
- Figure 20 Ditch 1/Remnant segment: Ponded area upstream of main beaver dam.

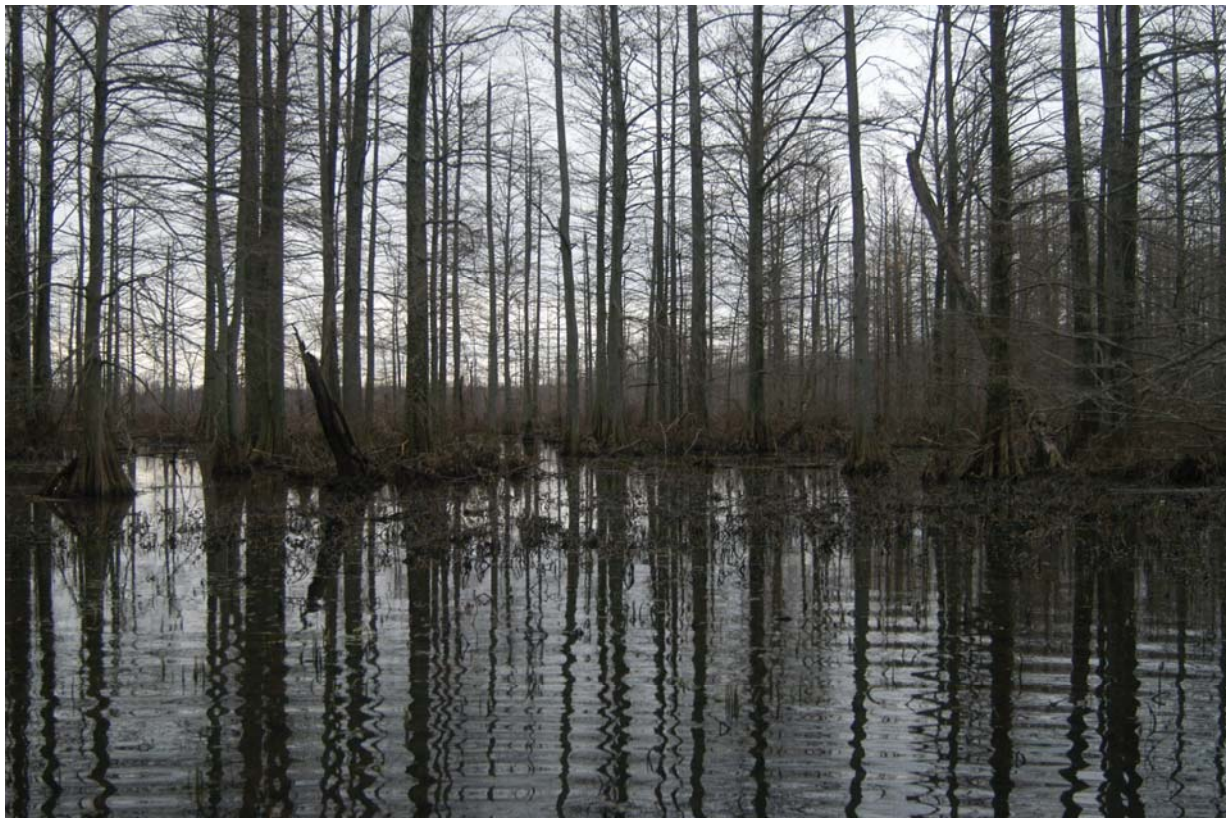
**Figure 20** Ditch 1/Remnant segment: Ponded area upstream of main beaver dam.
