Mitigation Plan for

Obion Creek (Phase II) and Little Joe Creek, Hickman County, Kentucky

Submitted: December 15, 2009

The Stream Institute
Department of Civil and Environmental Engineering
University of Louisville
Louisville, Kentucky 40292

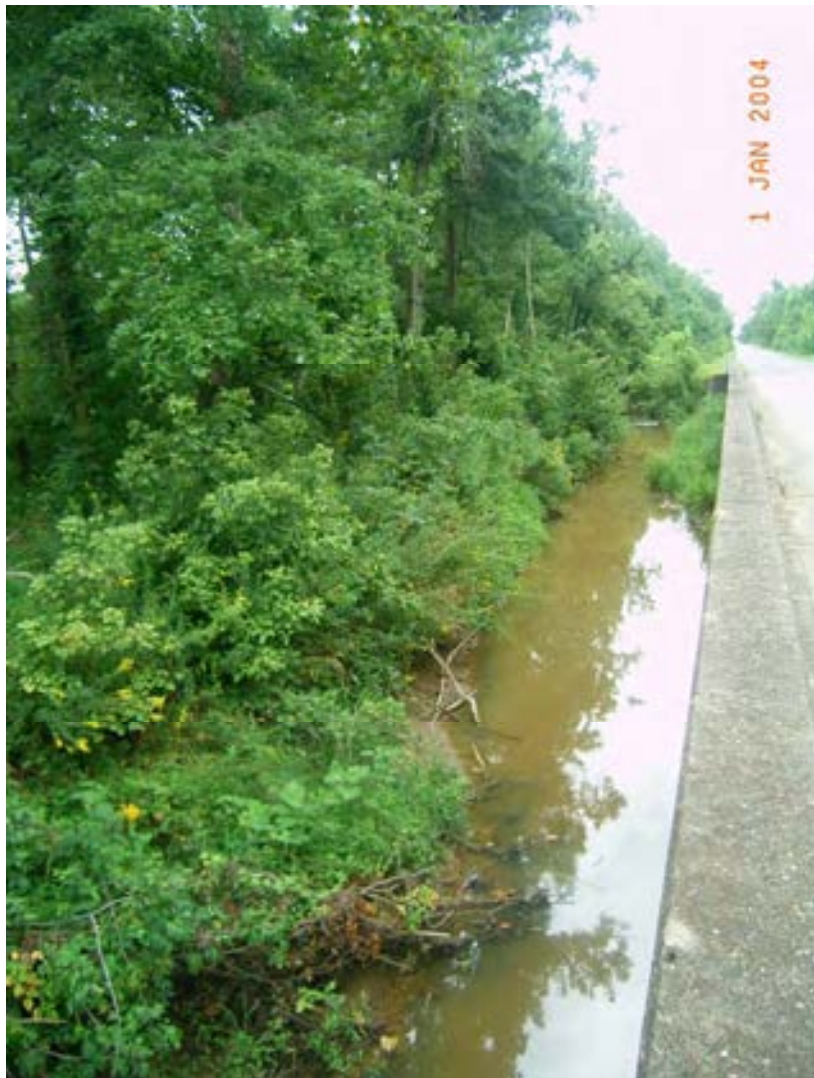
Figure 8 (Right) Little Joe Creek at upstream limit of restoration reach looking downstream.

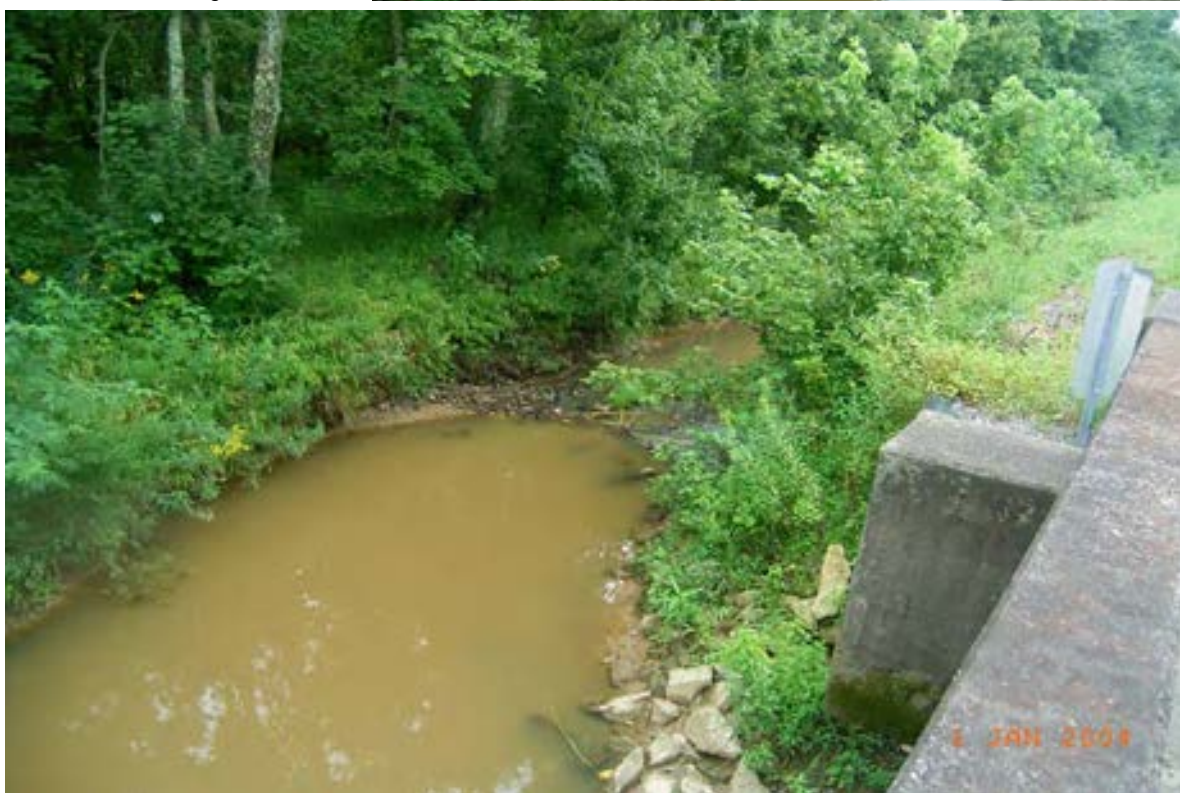
Figure 9 (Below) Little Joe Creek looking downstream along the upstream (east) side of the north KY-307 crossing.

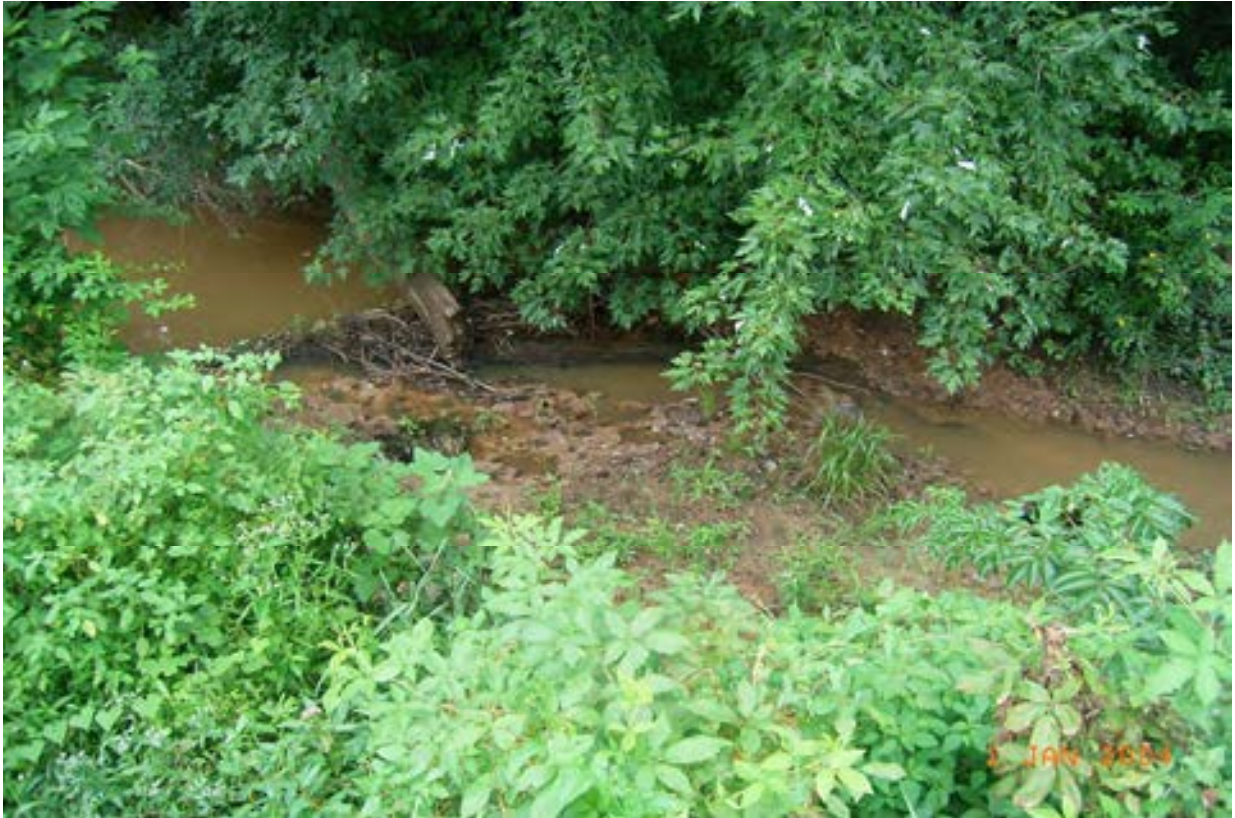
Figure 10 Knickpoint progression through clay substrate of Little Joe Creek; woody debris placed by beavers.

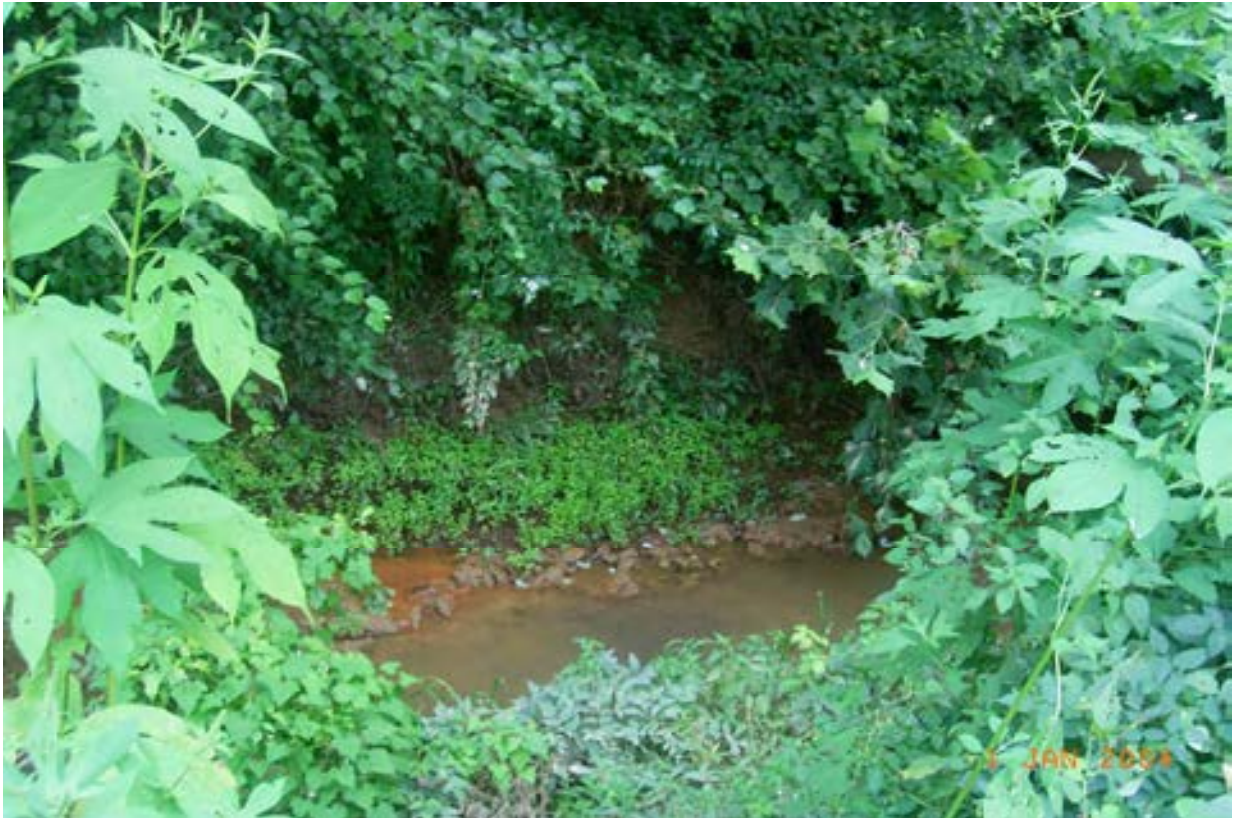
Figure 11 Little Joe Creek: Clay substrate, vegetated low bench, and bank erosion.

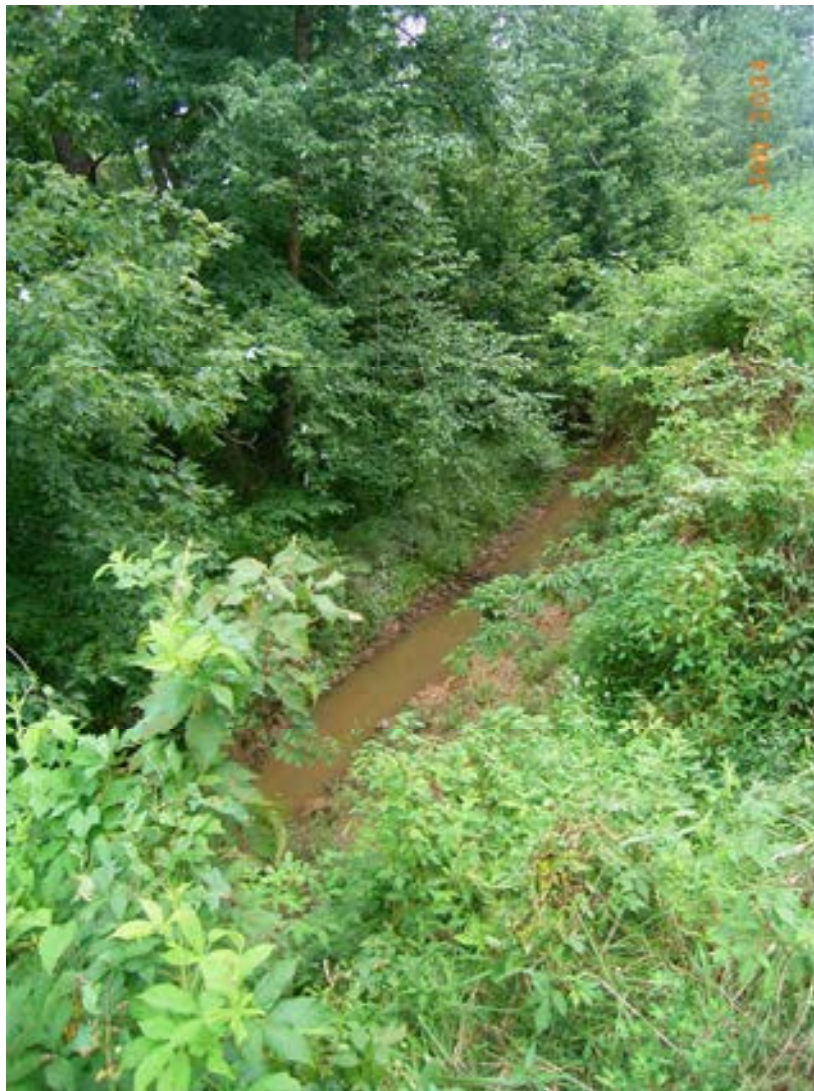
Figure 12 (Right) Bank erosion on right bank side of Little Joe Creek; straight channel alignment.

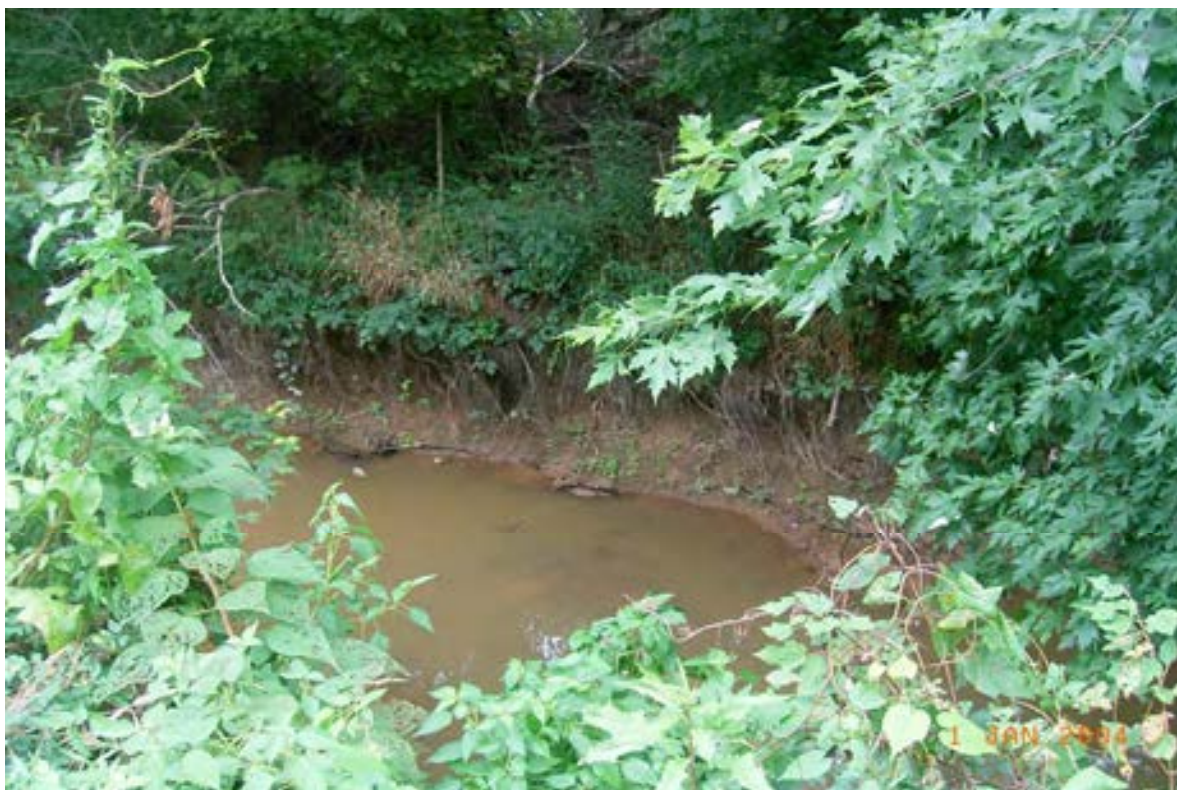
Figure 13 (Below) Little Joe Creek: Undercut bank upstream of confluence with Ditch 1.

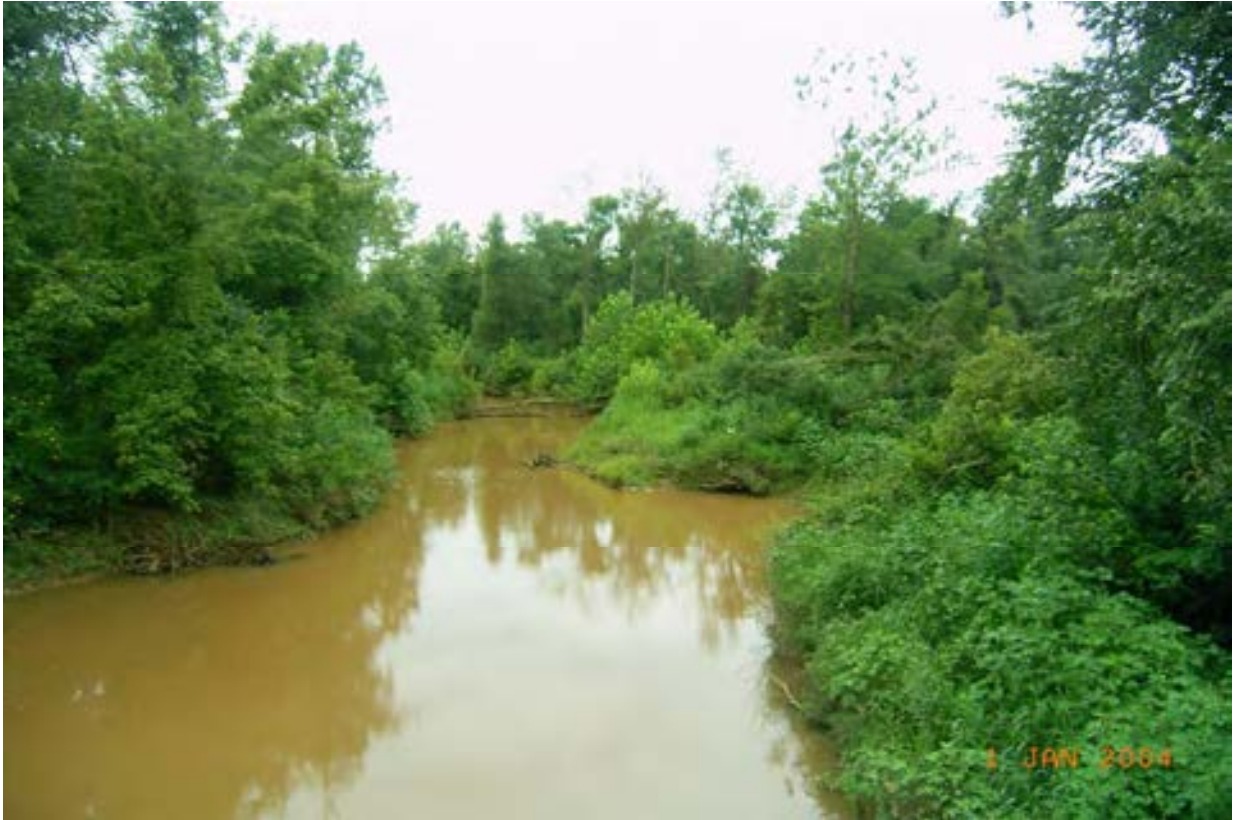
Figure 14 Phase I Obion Creek channel downstream of KY-307 (downstream view).

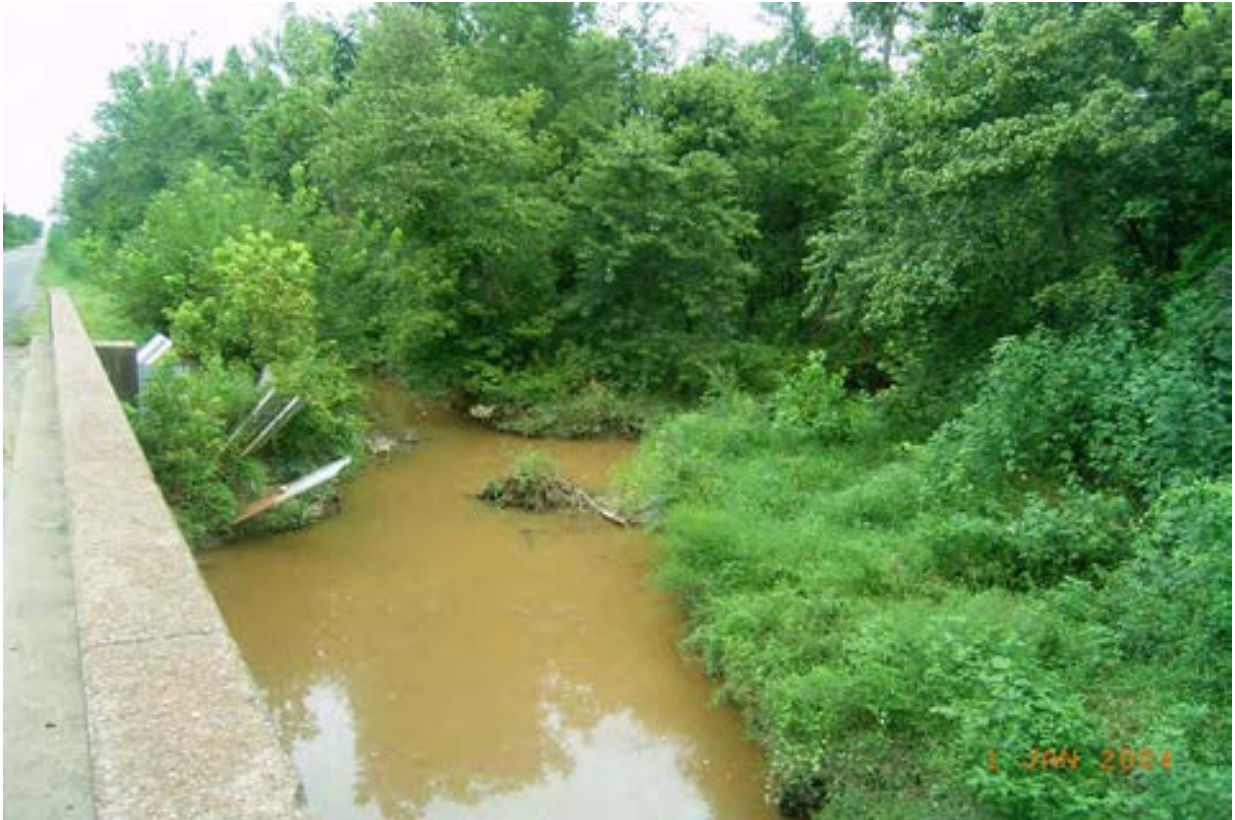
Figure 15 Upstream view of confluences of Obion Creek (bottom of photo), Little Joe (center left), and Ditch 1 (center right).

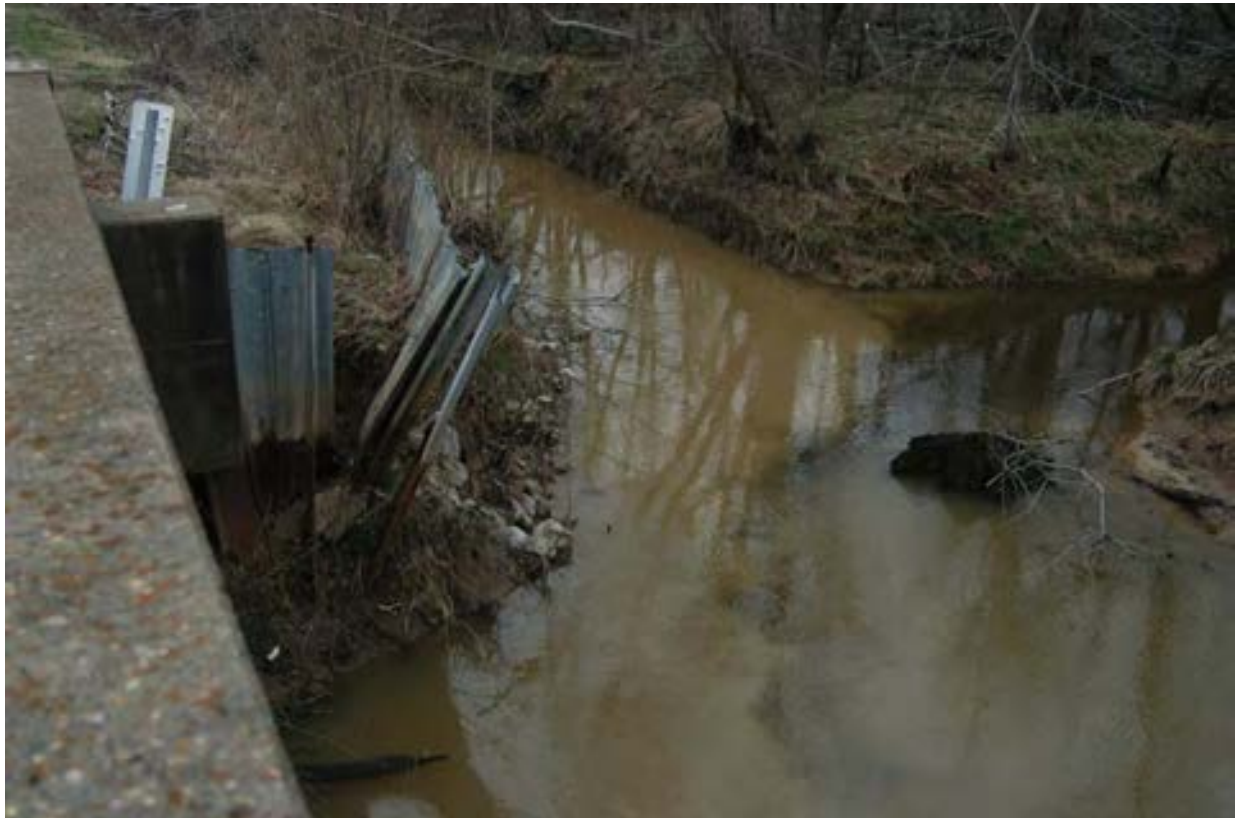
Figure 16 Ditch 1 confluence with Little Joe Creek.

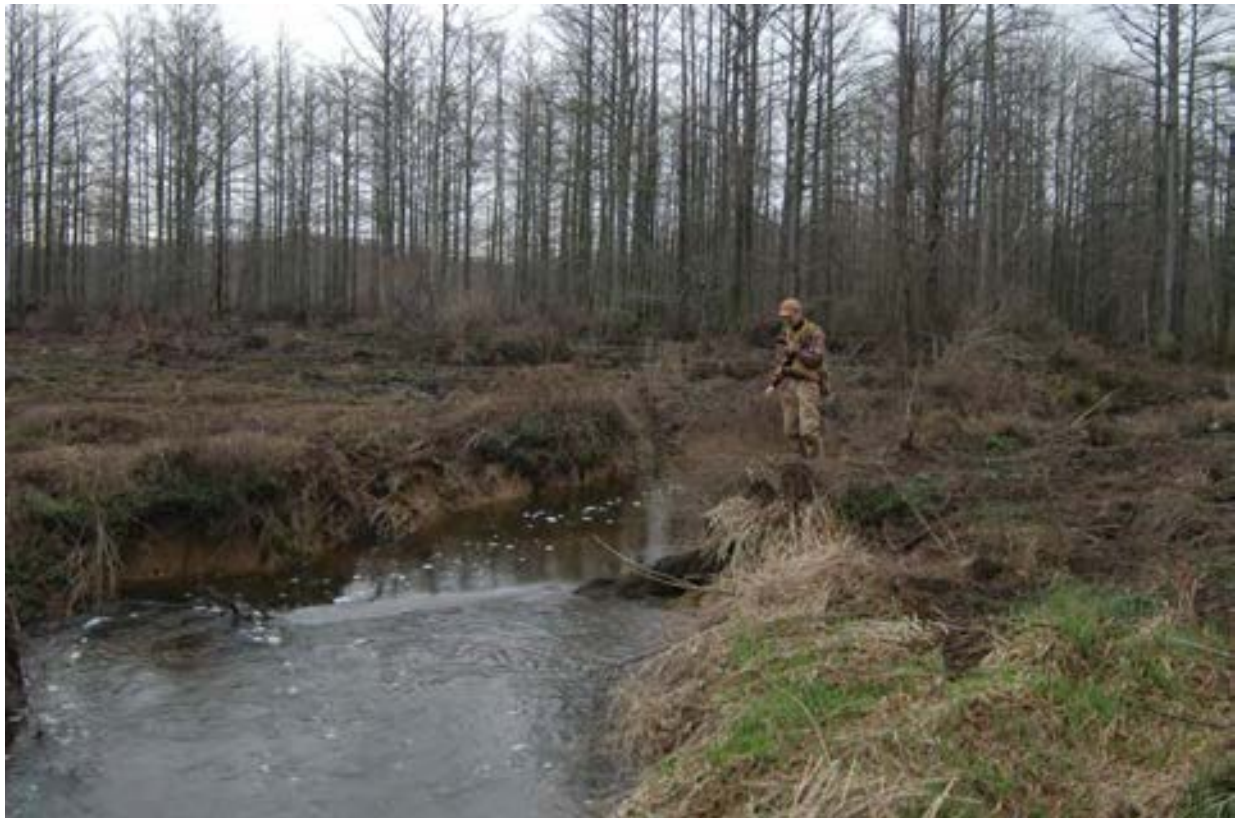
Figure 17 Looking upstream at bank erosion on Ditch 1.

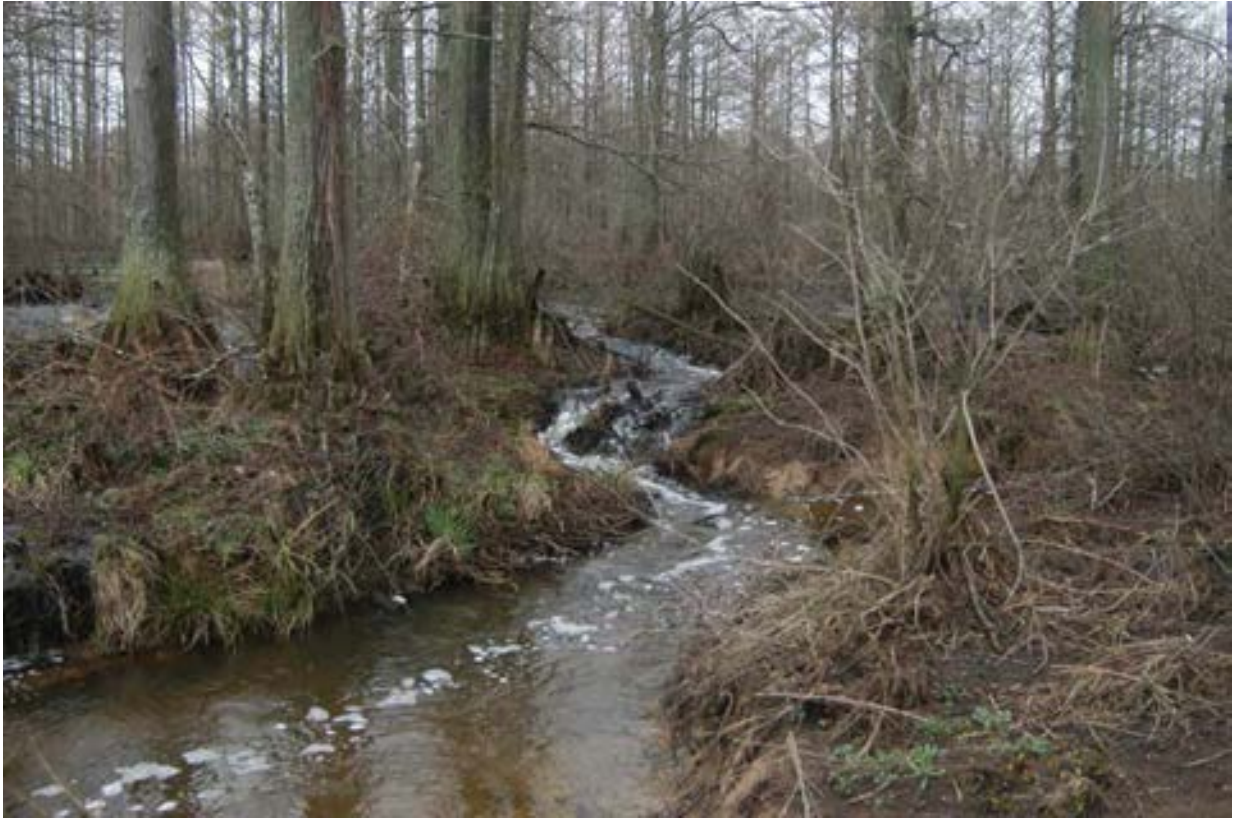
Figure 18 Looking upstream at Ditch 1 headcut over main beaver dam (at edge of power line corridor).

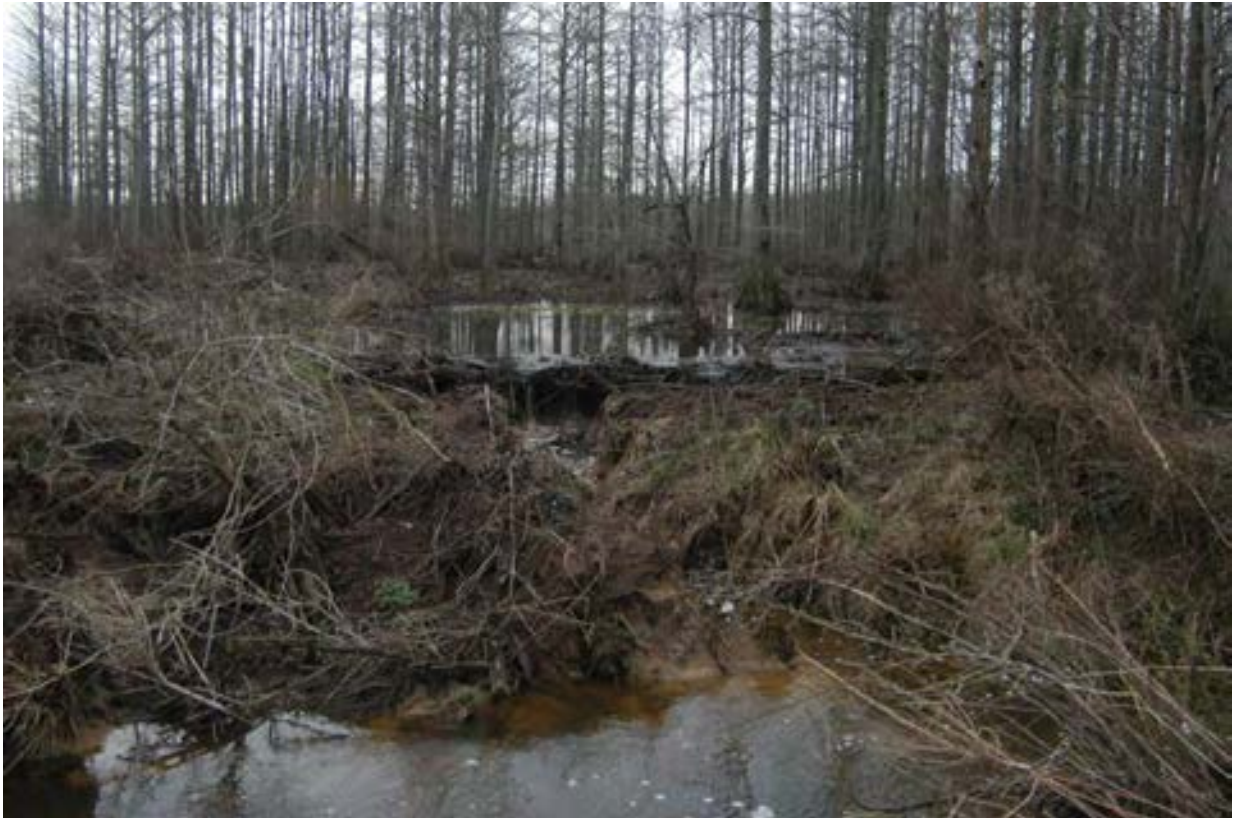
Figure 19 Turned 90° to the left from preceding photo of Ditch 1. Headcut/bank erosion from main beaver dam.

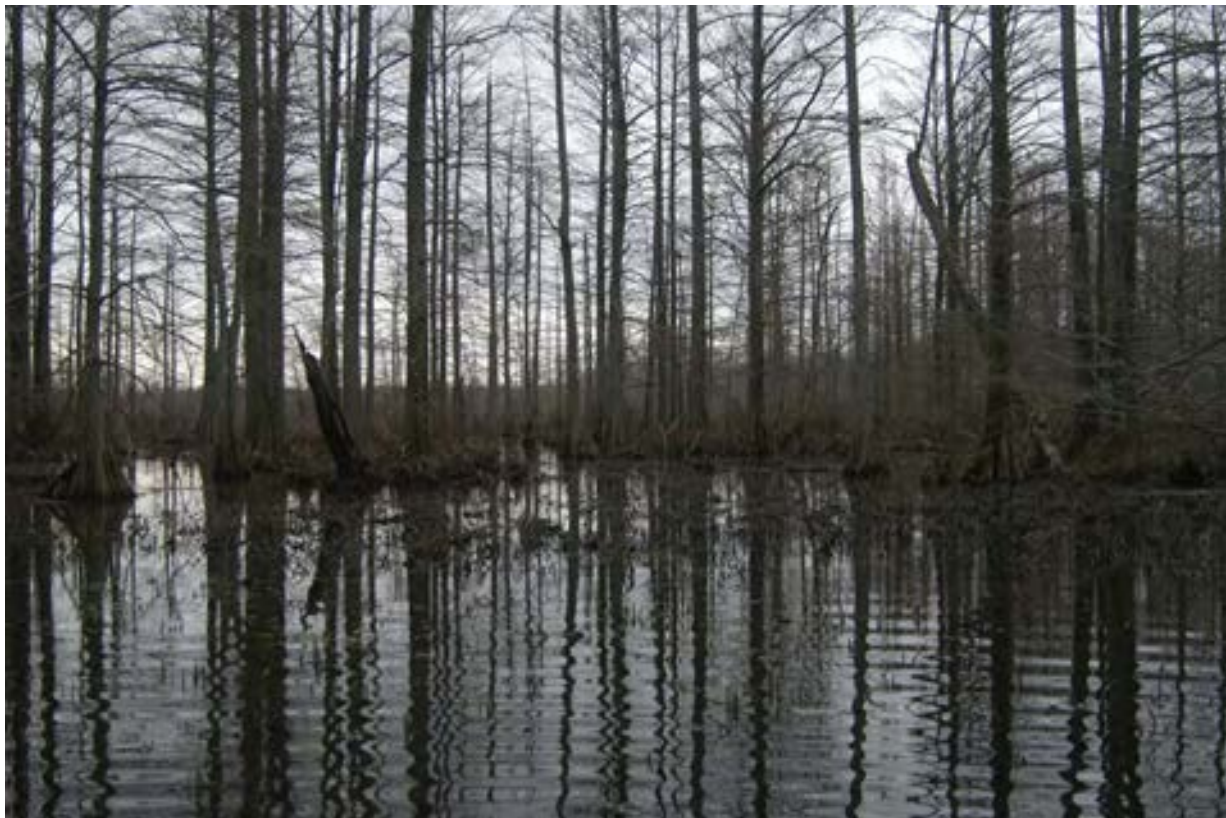
Figure 20 Ditch 1/Remnant segment: Ponded area upstream of main beaver dam.

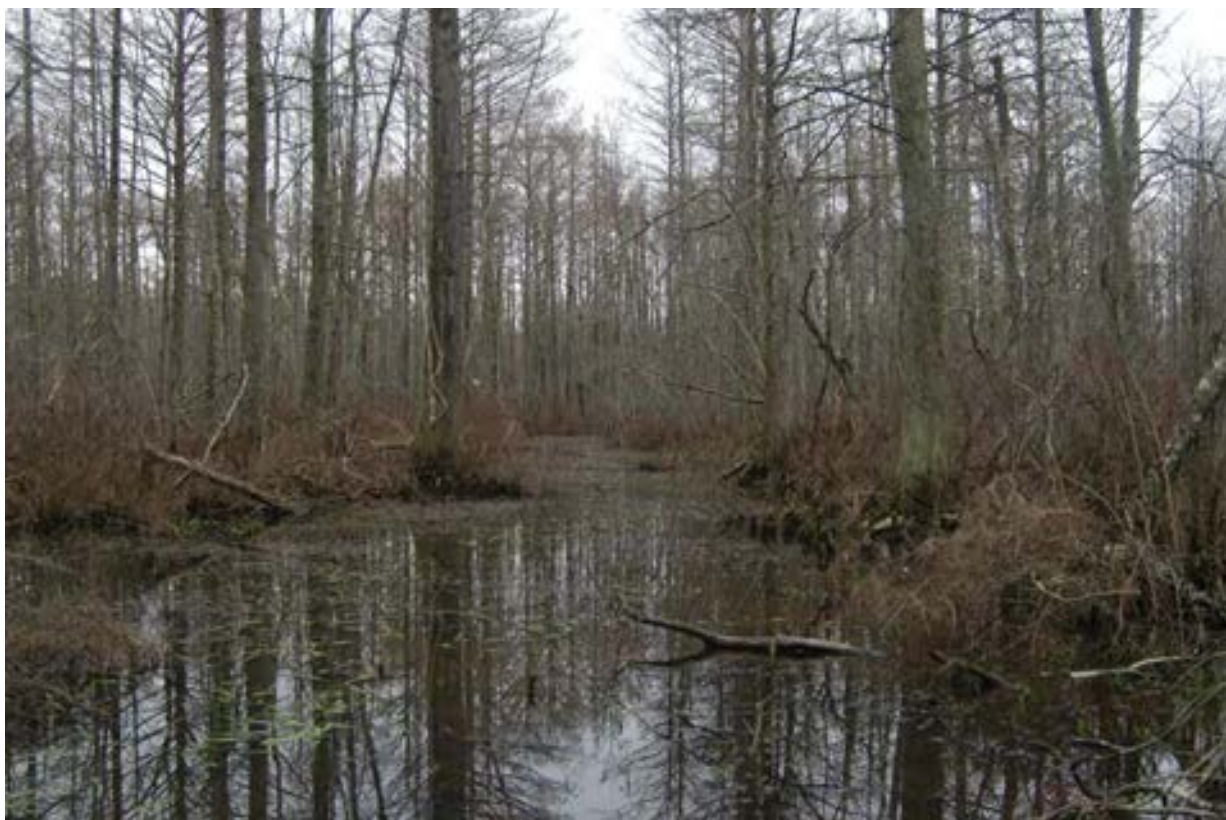
Figure 21 Remnant Obion channel in ponded area.

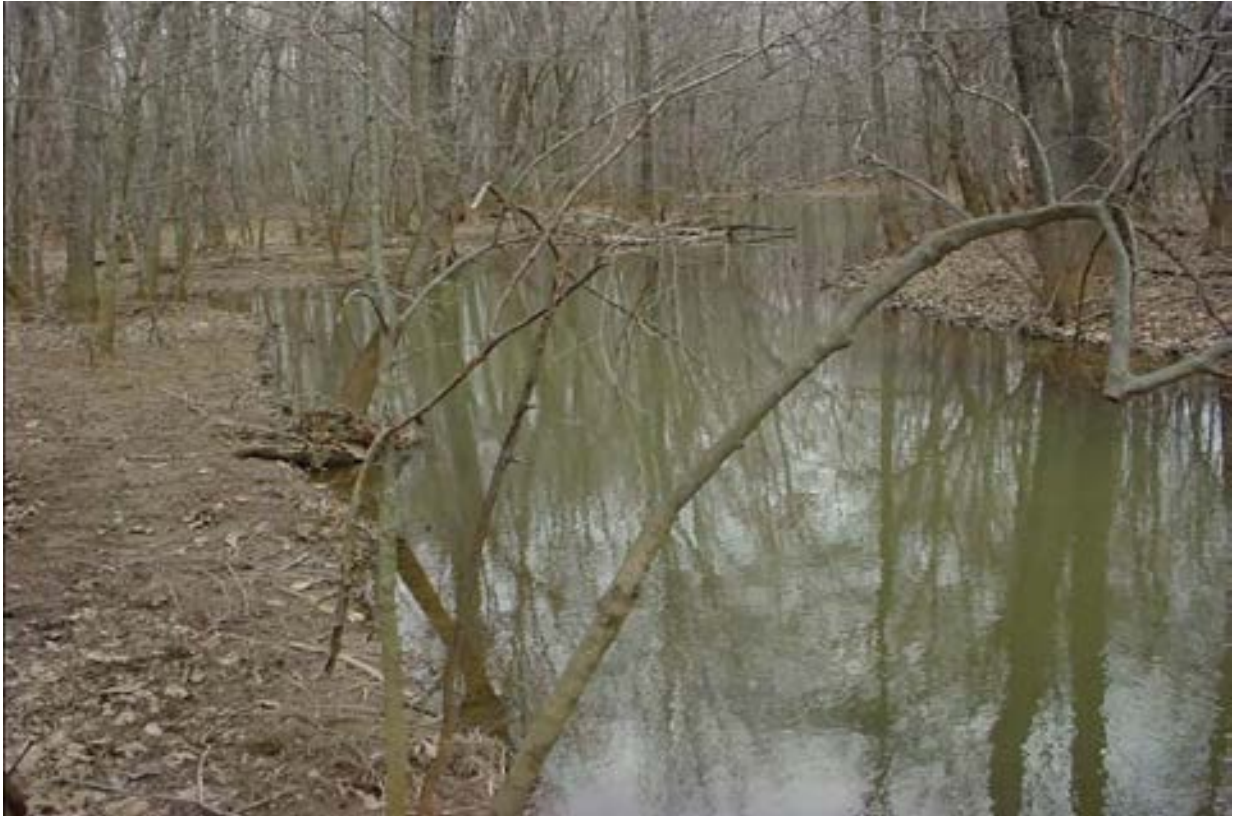
Figure 22 Remnant Obion channel near upstream end of mitigation site.
